**PARK CITY MUNICIPAL CORPORATION
HISTORIC PRESERVATION BOARD
SPECIAL MEETING
CITY COUNCIL CHAMBERS
January 16, 2018**

269 Daly Avenue – HDDR Material Deconstruction and Reconstruction – The applicant is proposing to reconstruct the historic house and historic garage designated as “Significant” on the City’s Historic Sites Inventory. In addition the applicant will be removing existing non-historic fences, a non-historic addition on the southwest corner of the house, the roof structure, one deteriorated chimney, exterior walls and layers of non-historic siding, non-historic front porch, non-original front door, and non-historic windows on the historic house. The applicant is only proposing to modify the garage doors as part of the reconstruction of the historic garage.

269 Daly Avenue Developmental History:

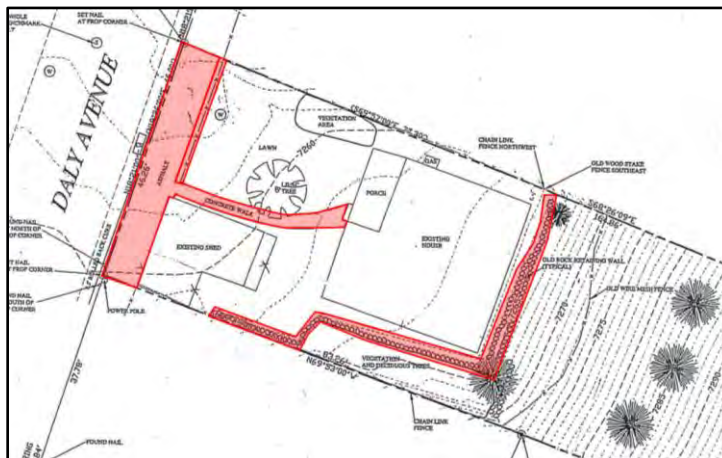
A. Site Improvements

There is nothing of historical significance in the yard that needs to be maintained. The front of the yard is characterized by asphalt parking strip as well as a wood picket fence. A non-historic concrete walkway leads to the front porch. There is an old rock retaining wall that wraps the south property line, around the house, and extends to the north lot line. The improvements are outlined in red.

The applicant is proposing to remove these improvements as part of their site improvements. In the future, an addition will likely be built where the existing rock retaining wall exists. Staff finds that the fence, sidewalk, and asphalt parking strip do not contribute to the historic integrity or the historical significance of the structure or site. Staff does find that the old rock wall is likely historic and contributes to the historic character of the site; the proposed scope of work mitigates any impacts that will occur to the visual character of the neighborhood because staff has included the following Condition of Approval:

#2. The applicant shall salvage rocks from the existing rock wall. These rocks shall then be reused on the site to construct any new retaining walls. If constructing an engineered retaining wall is necessary, the rocks can be used as a faux veneer over the concrete retaining wall.

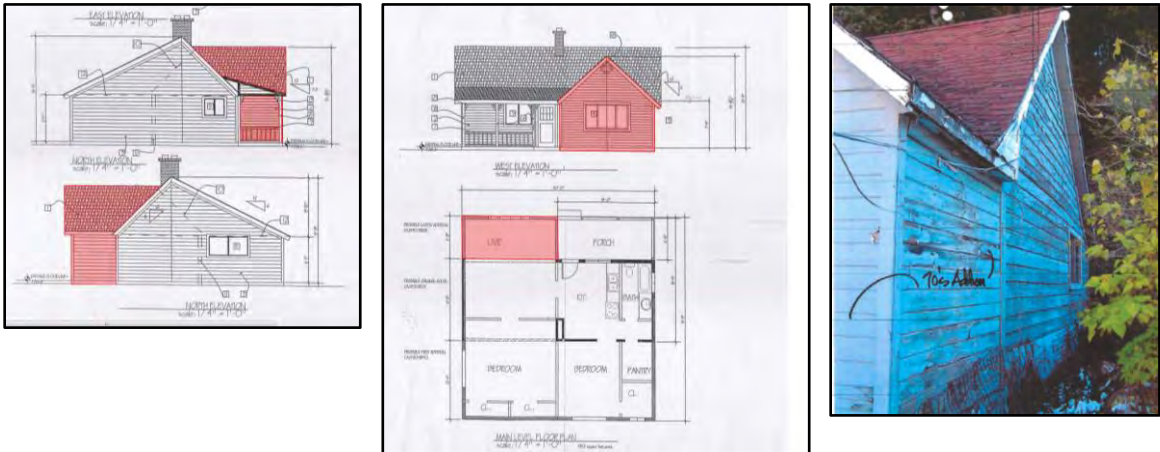
B. Additions

A gable cross-wing was added to the front of the original hall-parlor house between 1965 and 1970. This is evident by the difference in siding materials on the south elevation, differentiating the historic siding of the original side-gable from the 1970s siding of the addition. The roof eave was also altered to attach this new gable roofline to the addition. The HPB determined that this was an out-of-period addition as part of their review of the Determination of Significance application that demoted the site to “Significant” on September 18, 2013. This addition is highlighted in red below.

The applicant is proposing to remove this non-historic addition. The material deconstruction is necessary for the restoration of the hall-parlor’s original façade.

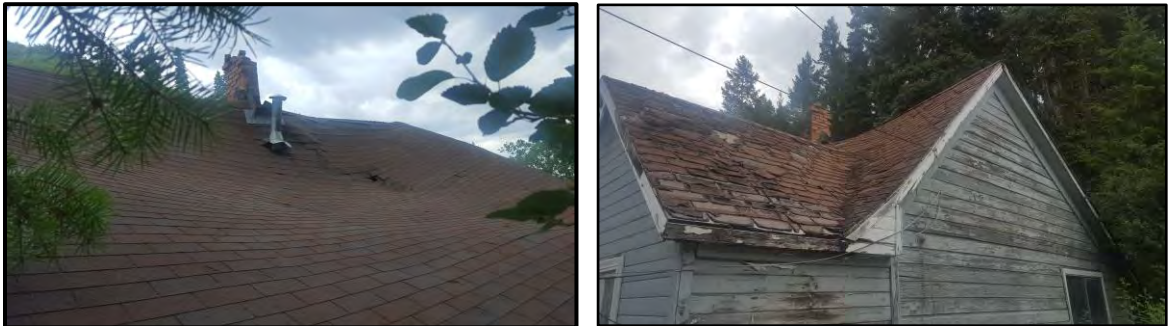
The roof structure is in noticeably poor condition with visible deterioration and a “wavy” appearance. The asphalt shingle roof has failed, partially due to the failing roof structure and partially due to age and deferred maintenance. Within the interior of the side-gable roof structure, the structural supports have bowed, detached, and created an unstable roof structure.

Water damage as well as the uneven settling of the house has caused the ceilings on the interior to bow. A broken roof support above the living room ceiling has broken through the ceiling, leaving it exposed to the leaky roof.

The roof needs to be reconstructed as it is in such poor condition that it is beyond salvaging or repairing/restructuring from the interior. Any material deconstruction of the roof is necessary as part of the restoration of the building.

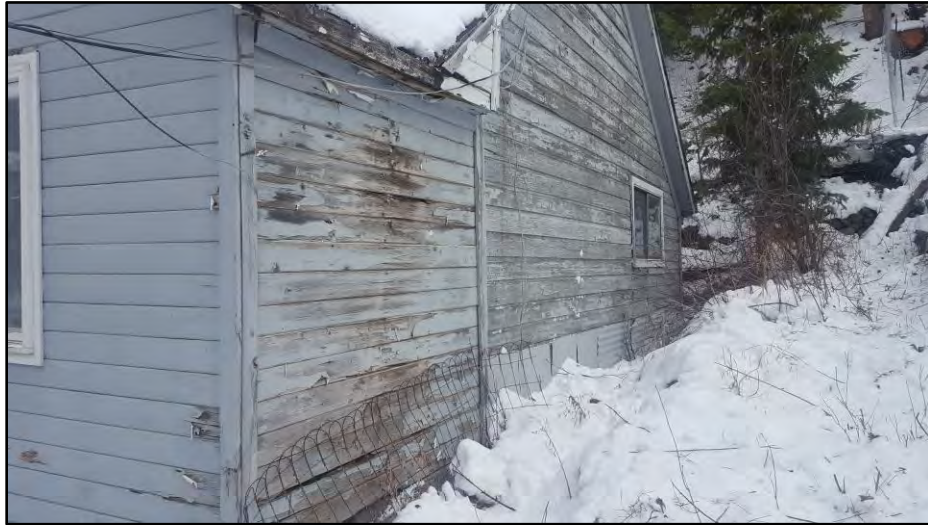
This house was built with single-wall construction and largely lacks structural integrity. The slow collapse and deterioration of the floor and roof structures have caused the walls to settle, buckle, and pull apart, as is evident in the applicant's Physical Conditions Report photos.

There are several styles of wood siding profiles on the exterior of the house, including shiplap and drop-novelty siding. Staff believes that all of these siding styles have been added at different periods of the house and as changes were made to the building, particularly around the 1970s addition.

The applicant is proposing to analyze and determine the original siding to determine if any can be reused or salvaged to re-mill new siding that matches the original. Staff finds that this material deconstruction is necessary for the restoration of the original hall-parlor house. Staff recommends adding the following Condition of Approval to address this:

#4. As the house is deconstructed, the applicant shall identify and analyze different siding profiles to determine the original siding profile. The applicant shall salvage and reuse any original siding materials that can be made safe and/or serviceable through repair.

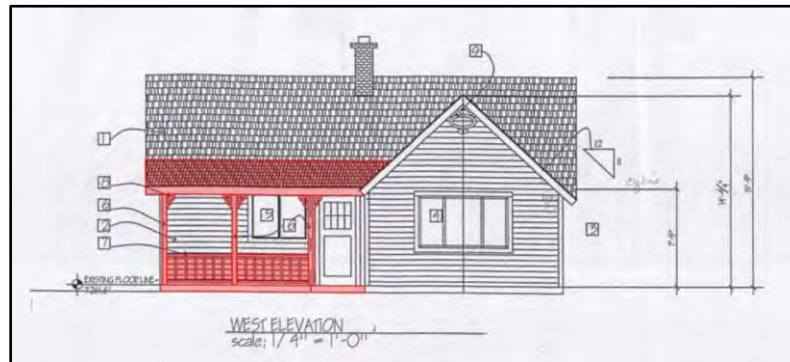
H. Porch

The existing porch is not original, but likely constructed during the 1980 remodel to the façade. The failure of the porch's floor structure has led to slumping and setting in different directions, causing the porch to pull away from the house. The porch floor is constructed of wood planks that have largely deteriorated due to wood rot and moisture. The railings are not historic and have deteriorated. There are decorative cornice pieces at the top of the wooden porch posts and the porch roof is failing. The porch has been highlighted in red below:

The materials that make up the porch are non-historic and beyond salvaging. The material deconstruction of the non-historic porch is necessary to restore the original porch to the reconstructed hall-parlor structure.

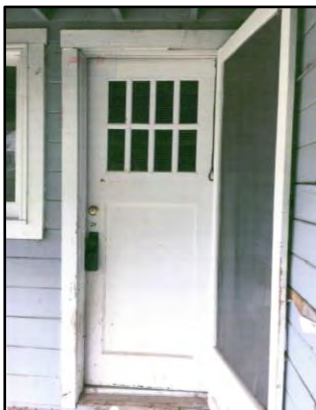
I. Doors

Only one existing historic door opening on the west facade. The wood paneled door has warped so badly due to the settling of the house that it is difficult to even close the door. It is a Craftsman-inspired door; however, it is likely not historic but a historic-inspired style that was installed within the last twenty years. A non-historic screen door is over the exterior door. The applicant is proposing to remove these doors and replace the exterior door with a new door of similar design.

Staff finds that the material deconstruction is appropriate as the door is not historic and does not contribute to the historic integrity of the structure. It is possible that original door openings will be uncovered during the material deconstruction of the house, as described further in the next section.

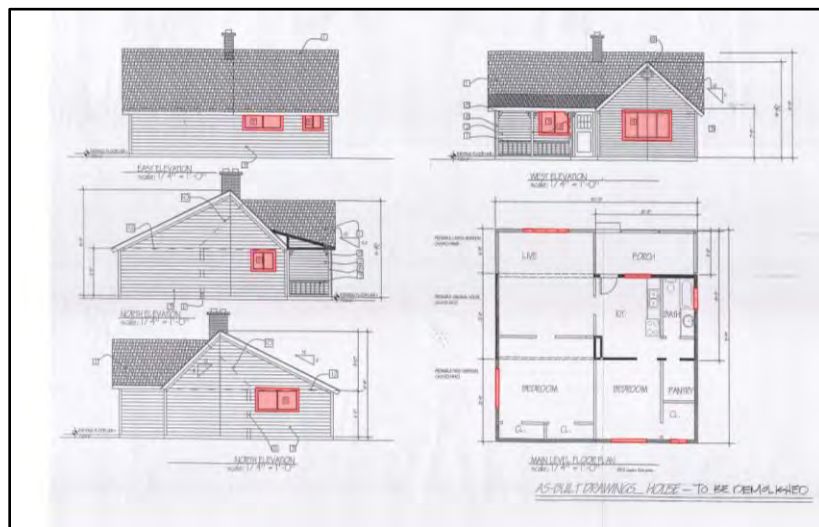
All of the existing windows in the house are in fair condition, but are not historic. They are comprised of wood, aluminum, and vinyl windows. On the northeast corner of the house, the windows are in poor condition and much of the glazing has been replaced with Plexiglass. Due to the house settling, the windows have warped and many are no longer operable. The existing windows have been highlighted in red below:

#8. The new windows on the historic house shall be wood, double-hung windows consistent with what existed historically.

Staff finds that the proposed material deconstruction is necessary as these additions to the building do not contribute to its historic integrity or historical significance. Further, the material deconstruction is necessary in order to restore the original window configuration of the hall-parlor form.

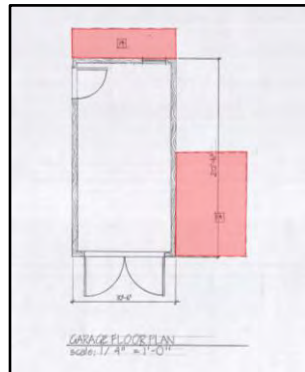
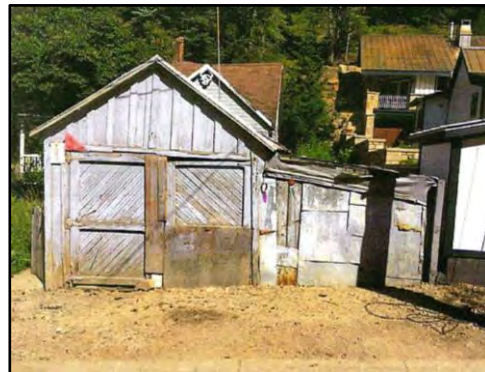
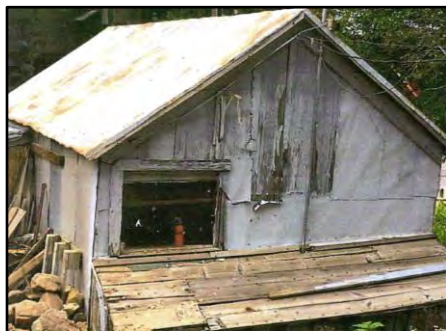
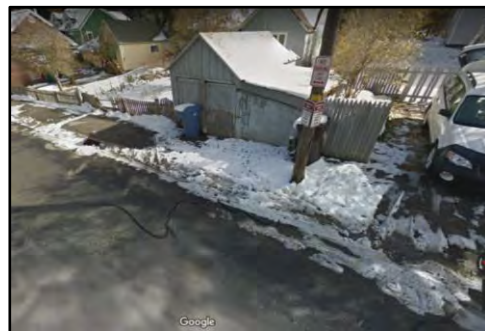
Two additions were constructed to the east and south elevations sometime after the Mature Mining Era (1894-1930). The east addition on the back consists of an exposed wood plank roof with board and batten siding; it is unclear what the purpose of this addition as. The addition on the south side of has a shed roof and consists of plywood and sheet metal. It has a corrugated metal roof, similar to that of the historic garage. These additions are denoted in red on the plan and depicted in the photographs below:

The applicant is proposing to remove these two non-historic additions to restore the original rectangular shape of the garage. Staff finds that these additions do not contribute to the historic integrity or historical significance of the garage.

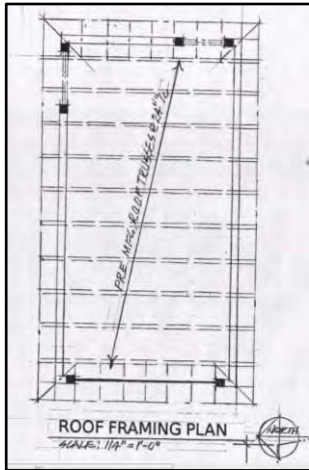
B. Roof

The existing roof above the historic garage consists of panels of corrugated steel. The surface of this steel has largely corroded, creating holes in the roofing that have rotted out the interior of the garage.

The roof structure is marginal at best. While the roof trusses are still holding the roof in-place, the structural members have begun to detach as the building has settled causing the roof to fail. The plan below is of the roof structure.

The applicant has proposed to completely rebuild the roof, matching the original in design, dimension, texture, material, and finish. Staff finds that the material deconstruction of the roof is necessary for the restoration of the historic garage.

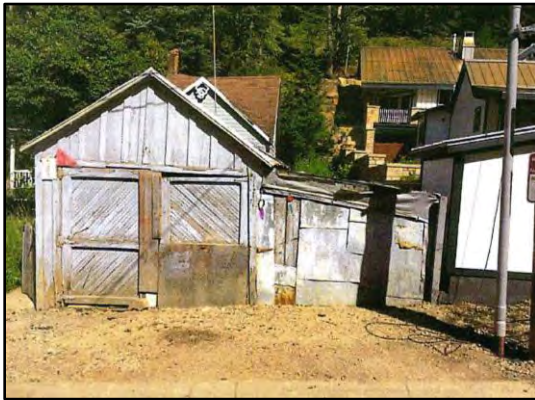
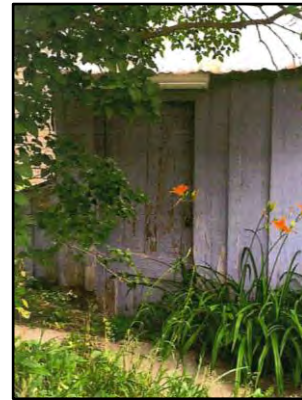
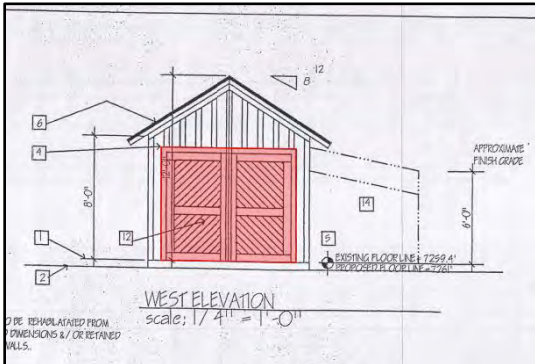
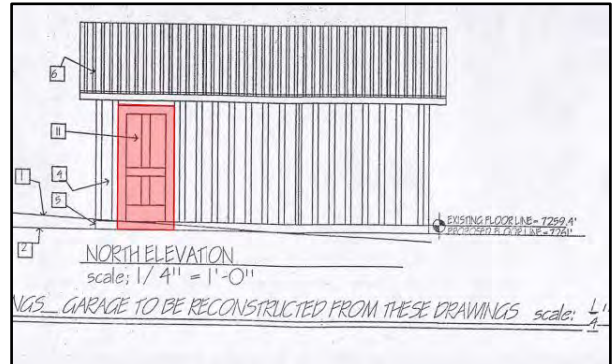
There is also an existing, historic four-panel wood service door on the north side of the garage. Much like the exterior walls, the overgrown landscaping and lack of foundation have caused the door to sit directly on the ground and rot. It is in poor condition and cannot be made safe and serviceable through repair.

The applicant is proposing to reconstruct both garage doors. Staff finds that the chevron-patterned panel door is a character-defining feature of this historic garage and needs to be reconstructed accurately. To ensure its restoration, staff has included the following Condition of Approval:

#9. The chevron-pattern panel garage door is a character-defining feature of this historic garage. As part of its reconstruction, the new garage door shall match the original in all respects: scale, dimension, texture, profile, material, and finish.

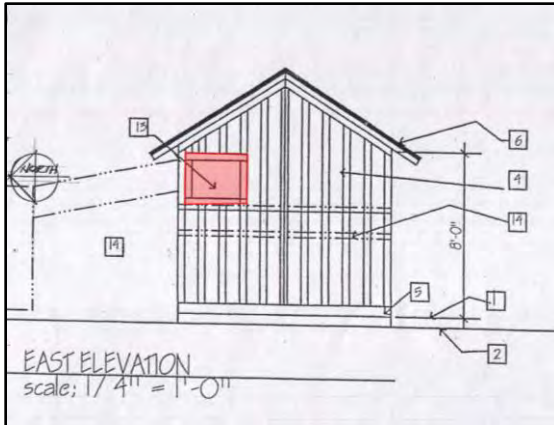
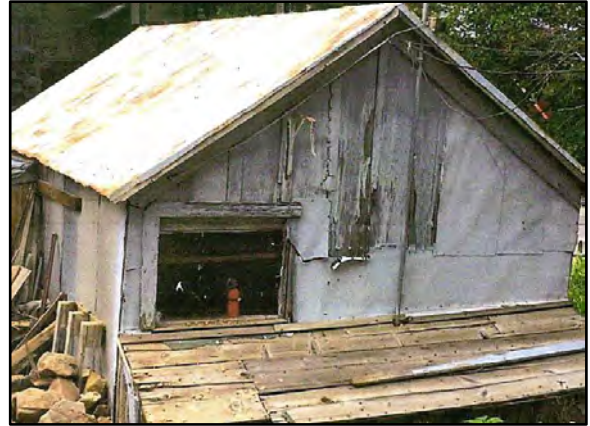
E. Windows

There is only one window in the historic garage, and it is located on the southeast corner of the building. The window is an undivided light, single-pane square-shaped window with a wood frame and wood trim.

The applicant proposes to incorporate a new window in the reconstructed garage. The material deconstruction is necessary in order to restore the original window configuration and restore the historic garage. Staff has added the following Condition of Approval:

#10. The new window on the historic garage shall be wood and match the existing in all respects: scale, dimension, texture, profile, material, and finish.
