PARK CITY MUNICIPAL CORPORATION HISTORIC PRESERVATION BOARD

February 1, 2017

REGULAR AGENDA – Discussion and possible action as outlined below 1063 Empire Avenue – Material Deconstruction – Significant designation. The applicant is proposing a remodel restoration: Secure existing structure for lifting; build new concrete foundation with basement and garage additions; re-position and anchor home on new foundation; restoration/renovation of historic home with a rear addition.

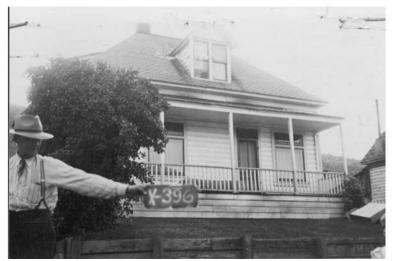
Figure D. ca. 1940s Tax Photo and ca. 1981 photo showing northern front porch addition

The two (2) most significant modifications to the overall form of the structure are the enclosure of portions of the front porch in order to gain interior space. Sometime after the 1941 tax photograph and before 1981 (See Figure D), the north half of the porch was enclosed to create living space. In doing so, the front door was relocated from the façade of the house to the south wall of the porch enclosure, changing the orientation of the entrance. The addition was clad in drop novelty wood siding to match the existing house. Additionally, two (2) large leaded glass windows with transoms on the front of the house were lost when this portion of the porch was enclosed, with the left window opening remaining, but with altered dimensions.

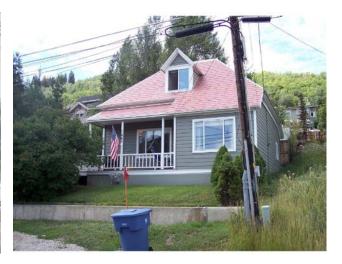
Figure E. Front façade in 1995 and 2006

The second porch enclosure becomes apparent when comparing the ca. 1981, 1995, and 2006 photos (southeast corner of house is blocked in 1940s photo by a shrub). The 1981 photo shows a wrap-around porch on the southeast corner, and the existence of a second entry door that faces the street. The addition, which enclosed the abovementioned inset porch and created a new, south-facing entryway, is not obvious (but exists) in the 1995 photo, and is clear in the 2006 photo (Figure E). A vertical board to the left of the large divided-light picture window likely marks where the building wall once terminated. It also appears that the original wood porch skirt was replaced with a new concrete foundation between the 1940s and 1981.

The renovation of the site includes the pouring of a new concrete foundation to provide a full basement and one-car garage. To provide access to the new garage and make room for a driveway, a portion of the existing non-historic concrete retaining wall that lines the street must be cut back. The 1940s tax photo shows the existence of a street-fronting retaining wall made of wood railroad ties, but by 1995 the wall was reconstructed of concrete. The tax photo from 1981 does not provide a view of the wall area (refer to Figures D and E, above).

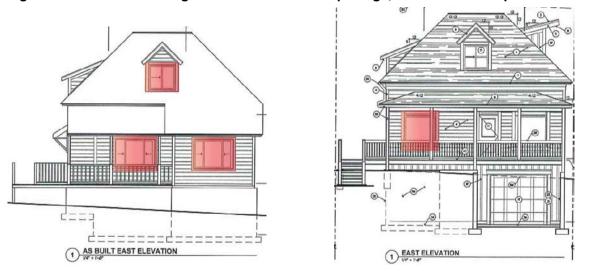
Figure G. Restoration of original window and door openings; relocation of left picture window

As part of the restoration of the full-width front porch, the applicant is proposing to restore the original window and door openings on the front façade of the home. This includes the restoration of a street-facing entryway with transom, as well as two large picture windows with transoms, which can be seen in the ca. 1940s photograph. The applicant is proposing to maintain the non-historic porch enclosure on the south end of the front porch that in-filled the original wrap-around porch; thus, is also proposing to shift the picture window to the left farther south on the façade than it was historically located, to visually balance the openings. *HPB Discussion Requested*. The applicant is also proposing to replace the non-historic vinyl slider windows with wood, double-hung windows on the street-facing dormer, which is a return to the historic style and material.

Staff finds that the material deconstruction of the current windows and doors is required for the successful restoration and renovation of the building. The addition of the French doors on the south side of the house is beyond the midpoint of the historic house and will not be visible from the right-of-way; staff finds that this proposed exterior changes shall not damage or destroy the exterior architectural features of the subject property which are compatible with the character of the historic site and are not included in the proposed scope of work.

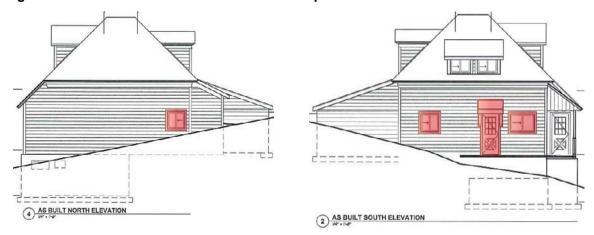
Figure H. Windows and door to be removed or replaced on North and South elevations

There is also a request to replace an existing small vinyl slider window with a wood casement window on the north façade, and to remove a non-historic window and door on the south façade, and add French doors with transom past the midpoint of the historic façade on that side.

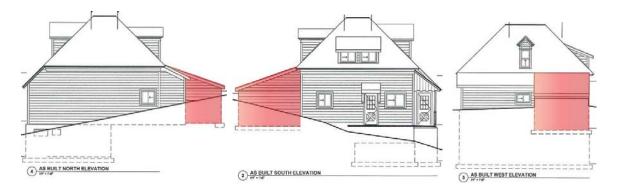
Figure I. North, South, and West elevations highlighting non-historic rear addition to be removed

The applicant is proposing to remove the small rear addition made of concrete block at the southwest corner of the home, in order to make way for the proposed new rear addition. It is estimated that this addition was constructed in the 1950s or 1960s, based on its materials and historic precedent in Park City.

Staff finds that the non-historic rear addition is non-contributory to the historic integrity or historical significance of the structure or site.

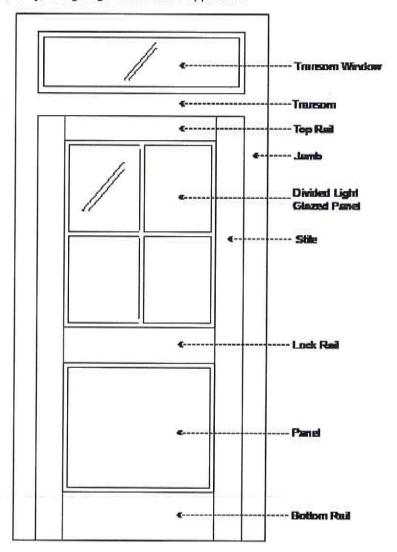
Total number of door openings on the exterior of the structure:	2
Number of historic doors on the structure:	0
Number of existing replacement/non-historic doors:	2
Number of doors completely missing:	0

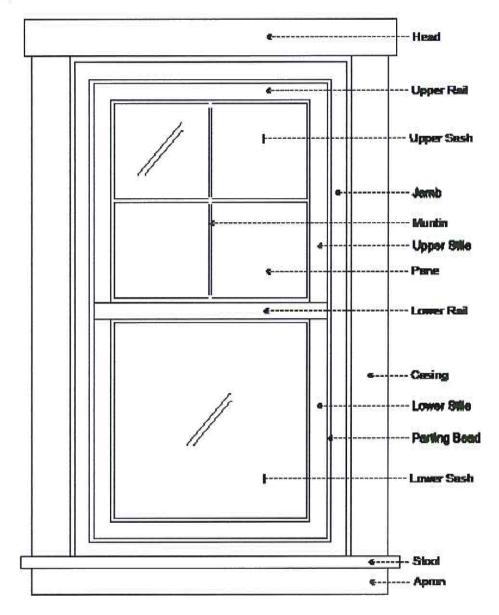
Total number of window openings on the exterior of the structure:	10
Number of historic windows on the structure:	0
Number of existing replacement/non-historic windows	10
Number of windows completely missing:	0

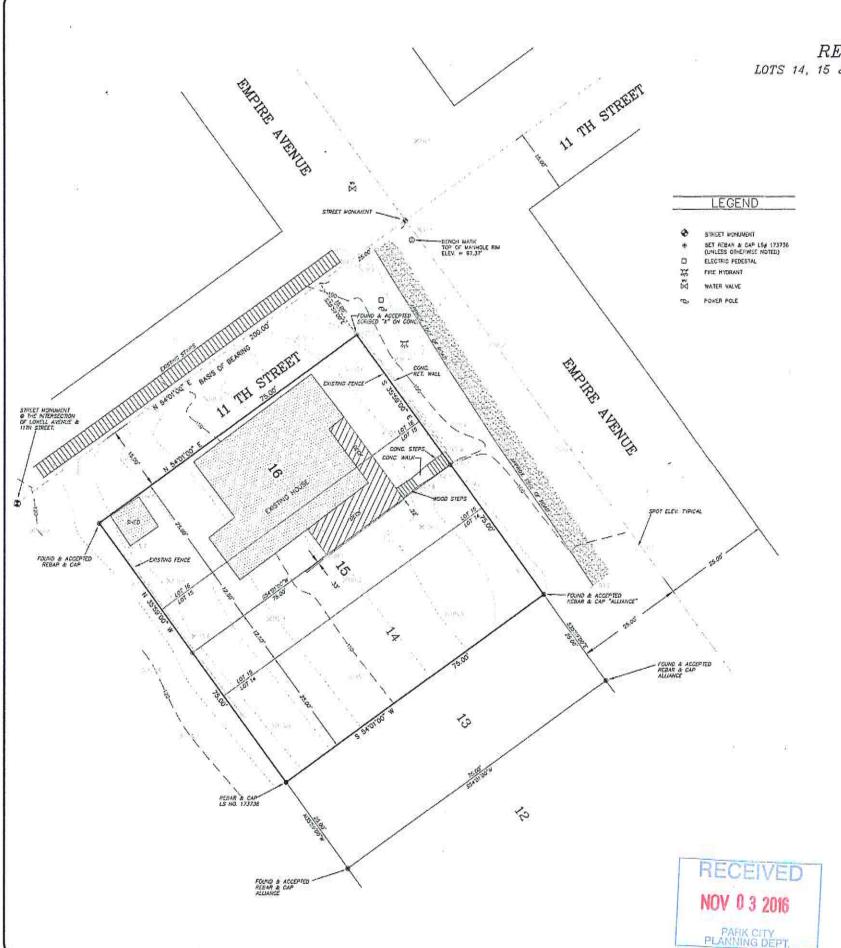
RECORD OF SURVEY & TOPOGRAPHIC MAP

LOTS 14, 15 & 16, BLOCK 28 OF THE SNYDERS ADDITION TO PARK CITY SURVEY
LYING WITHIN THE NORTHWEST QUARTER OF
SECTION 16, TOWNSHIP 2 SOUTH, RANGE 4 EAST SALT LAKE BASE & MERIDIAN SUMMIT COUNTY, UTAH

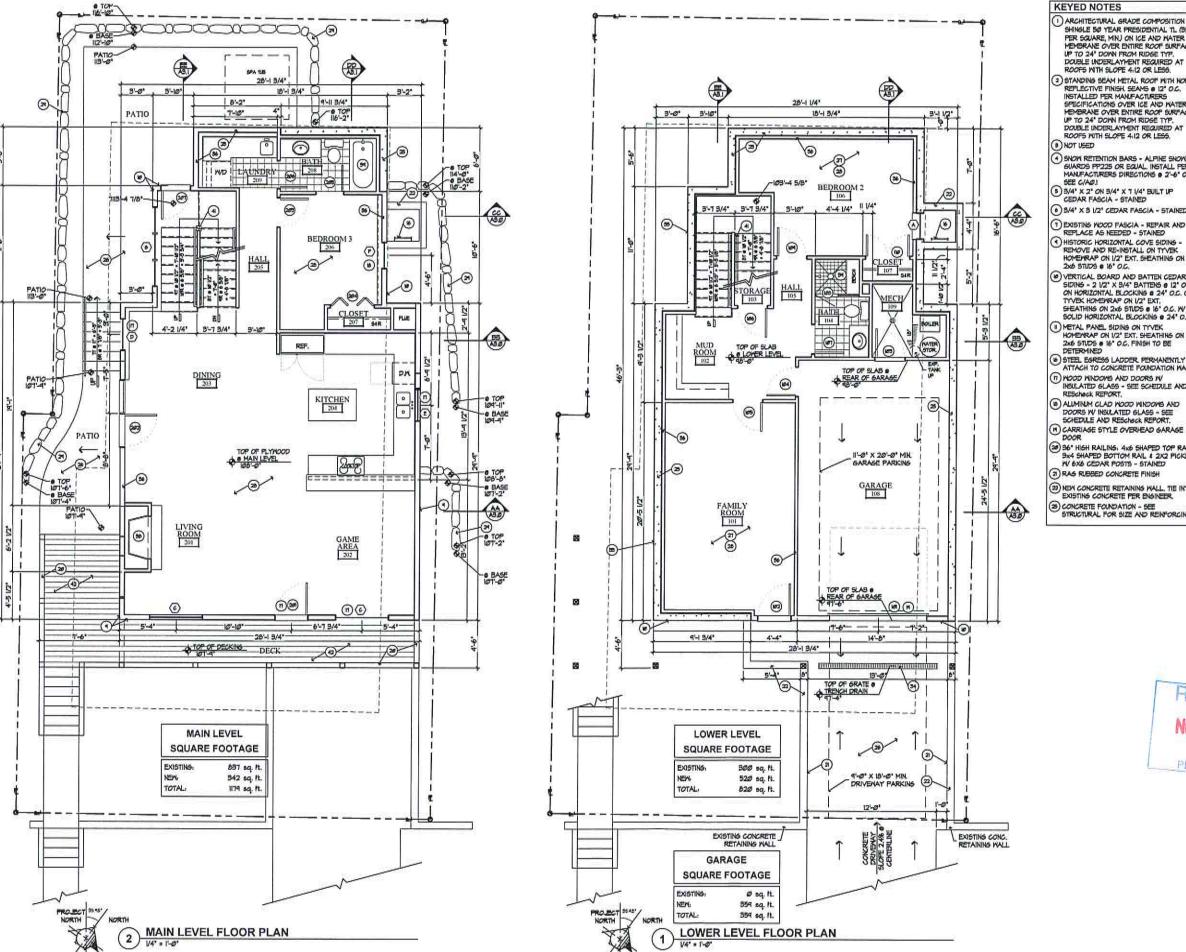
A0.2

ARCHITECTURAL GRADE COMPOSITION SHINGLE 50 YEAR PRESIDENTIAL IL (855# PER SQUARE, MIN.) ON ICE AND WATER MEMBRANE OVER ENTIRE ROOF SURFACE UP TO 24" DOWN FROM RIDGE TYP. DOUBLE UNDERLAYMENT REQUIRED AT ROOFS WITH SLOPE 4:12 OR LESS

(2) STANDING SEAM METAL ROOF WITH NON REFLECTIVE FINISH, SEAMS & 12" O.C., INSTALLED PER MANUFACTURERS SPECIFICATIONS OVER ICE AND WATER MEMBRANE OVER ENTIRE ROOF SURFACE UP TO 24' DOWN FROM RIDGE TYP. DOUBLE UNDERLAYMENT REQUIRED AT ROOFS WITH SLOPE 4:12 OR LESS.

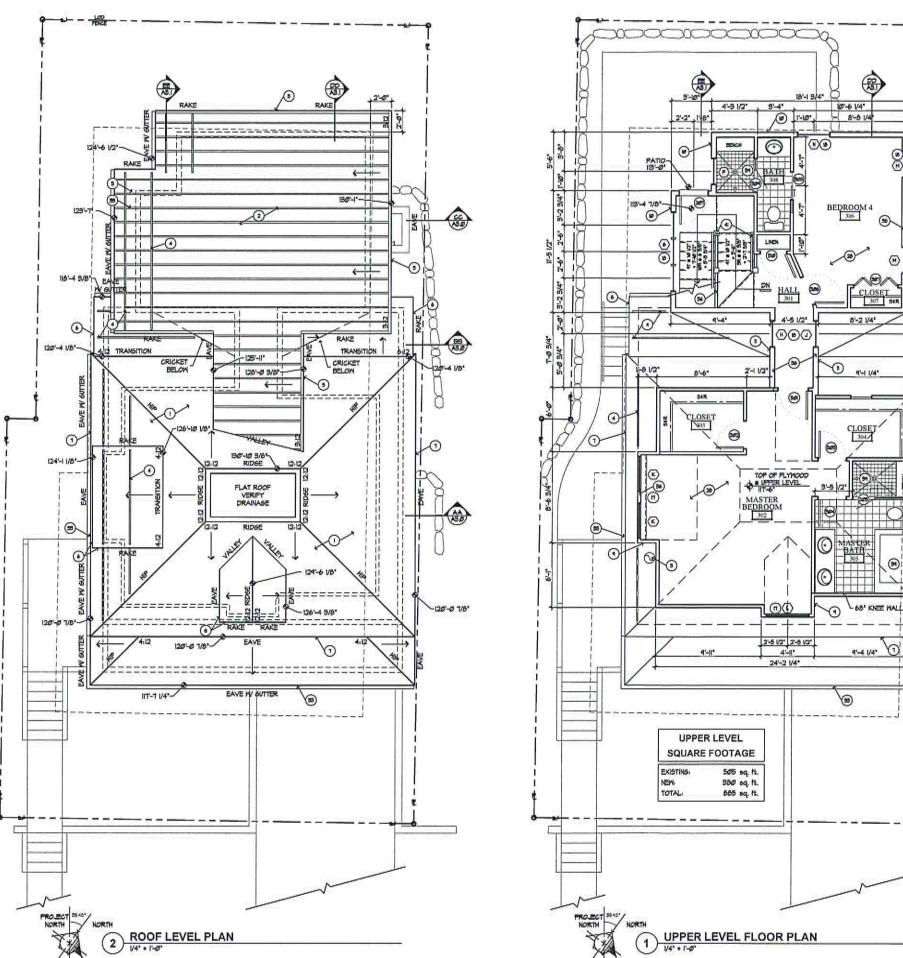
KEYED NOTES

ARCHITECTURAL GRADE COMPOSITION SHINGLE 50 YEAR PRESIDENTIAL TL (955) PER SQUARE, MIN) ON ICE AND WATER MEMBRANE OVER ENTIRE ROOF SURFACE ROOPS WITH SLOPE 4:12 OR LESS.

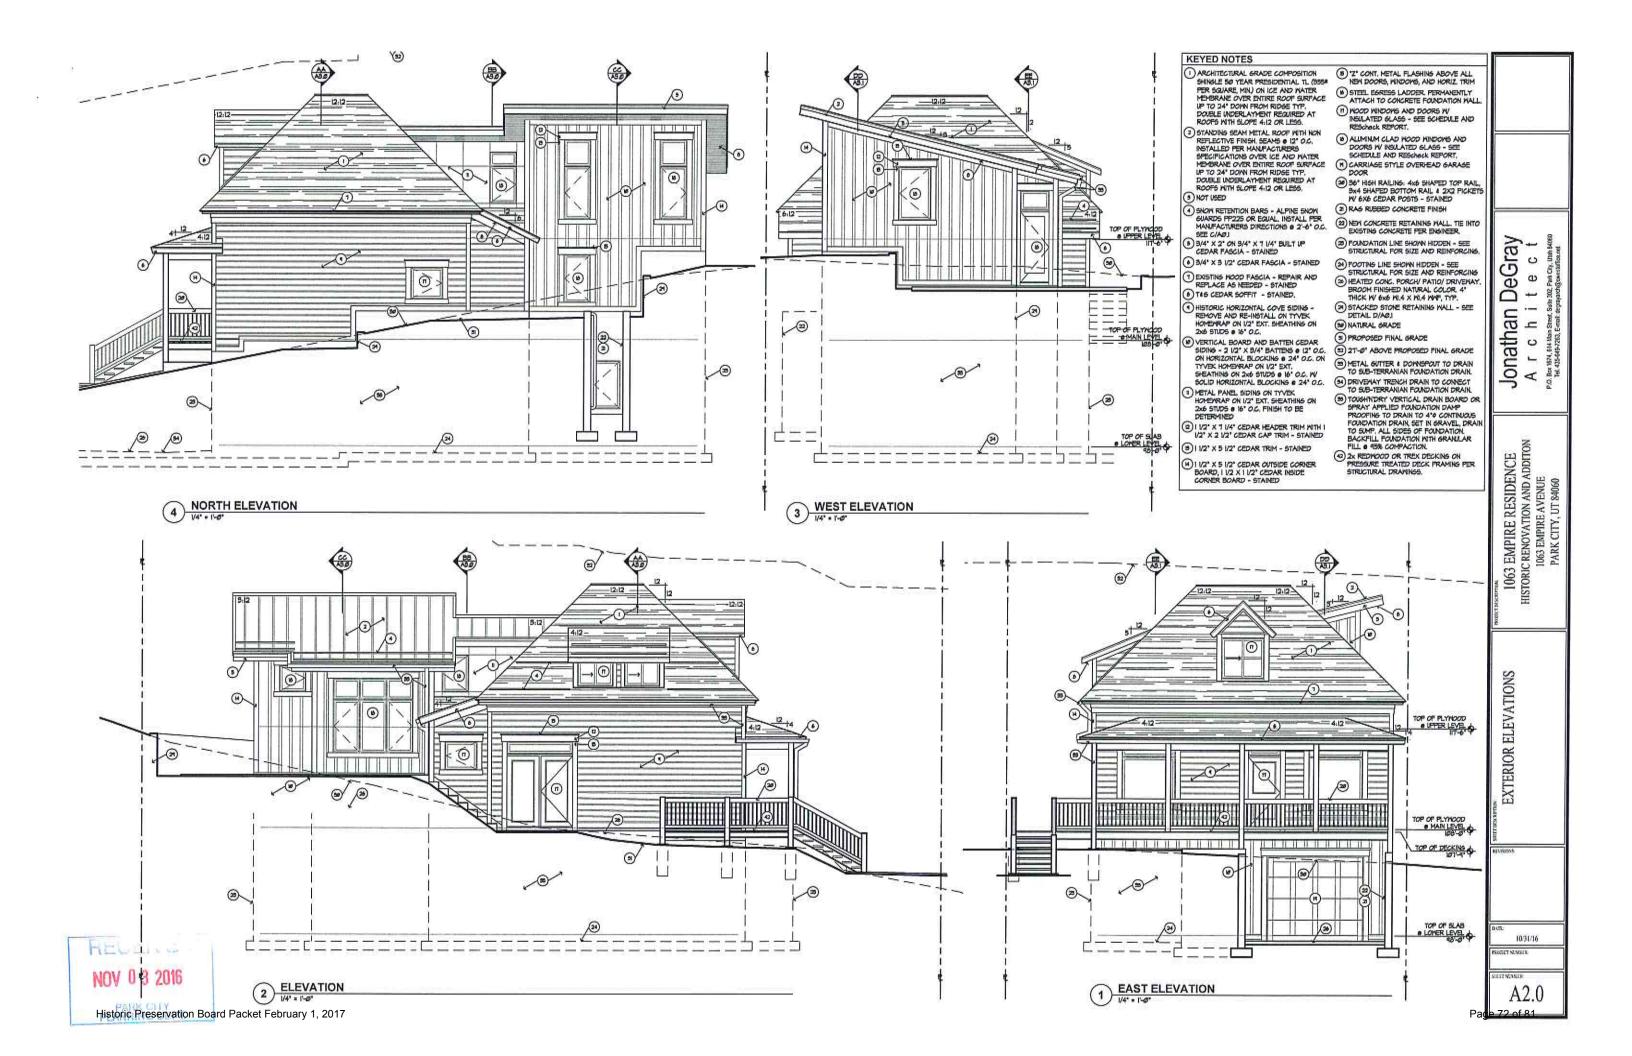
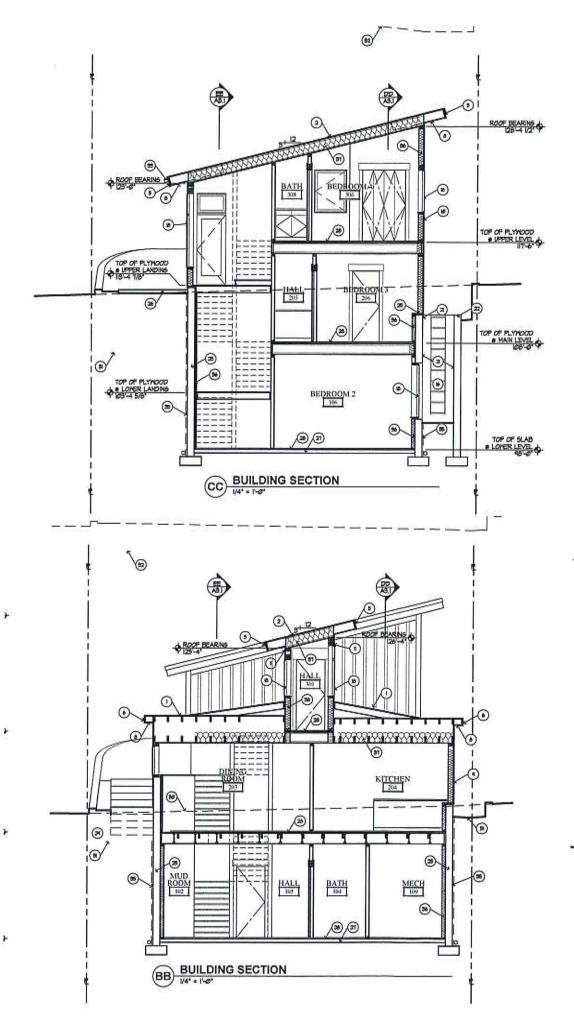
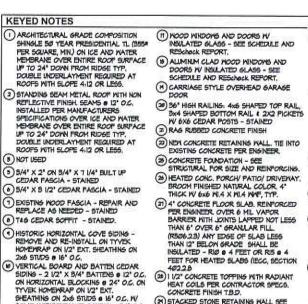
(20) 1 1/2" CONCRETE TOPPINS WITH RADIANT HEAT COILS PER CONTRACTOR SPECS. CONCRETE FINISH T.B.D. STACKED STONE RETAINING WALL SEE

SOLID HORIZONTAL BLOCKINS . 24" O.C. II METAL PANEL SIDING ON TYVEK HOMENRAP ON 1/2" EXT. SHEATHING ON 2x6 STVDS & 16" O.C. FINISH TO BE DETERMINED

(4) 2x REDMOOD OR TREX DECKINS ON PRESSURE TREATED DECK FRAMING PER STRUCTURAL DRAWINGS.
