**PARK CITY MUNICIPAL CORPORATION  
HISTORIC PRESERVATION BOARD  
CITY COUNCIL CHAMBERS  
December 5, 2017**

424 Woodside Avenue – HDDR Review for Reorientation - Reorientation (rotation) of a “Significant” Structure towards Woodside Avenue and lifting of the Historic Structure 7 feet 7 ¾ inches. The primary façade of the Significant Structure is currently oriented towards Main Street and the applicant is proposing to rotate the structure 180 degrees so that the primary façade is oriented towards Woodside Avenue. Upon reorientation, the Historic Structure would be lifted 7 feet 7 ¾ inches.

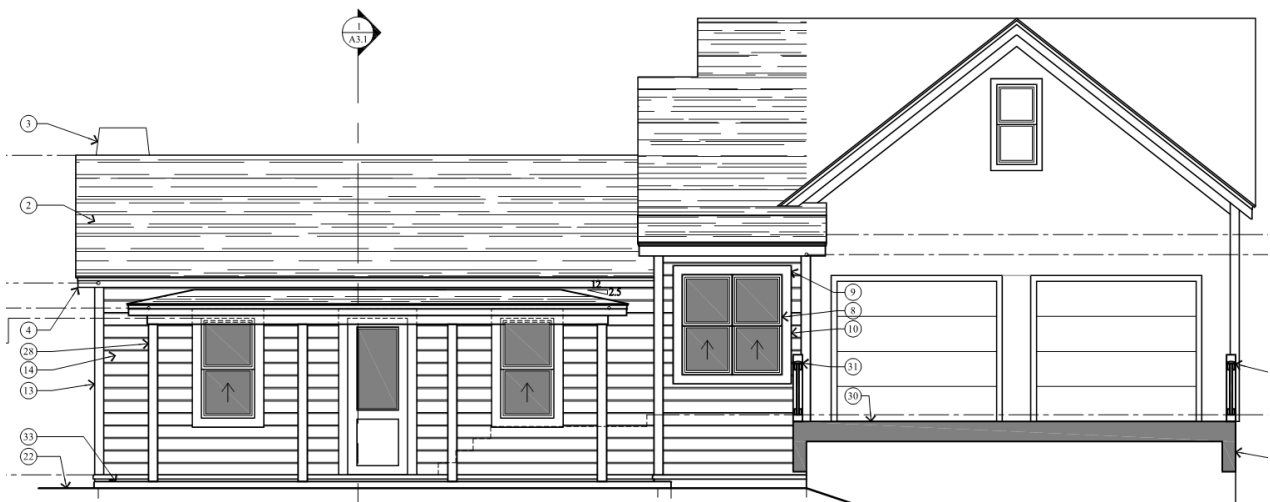
**Figure 2a: Proposed Reorientation – West Façade**

Figures 2a-2d identify the proposed reorientation of the Historic Structures towards Woodside Avenue (west). Renderings provided by Jonathan DeGray.

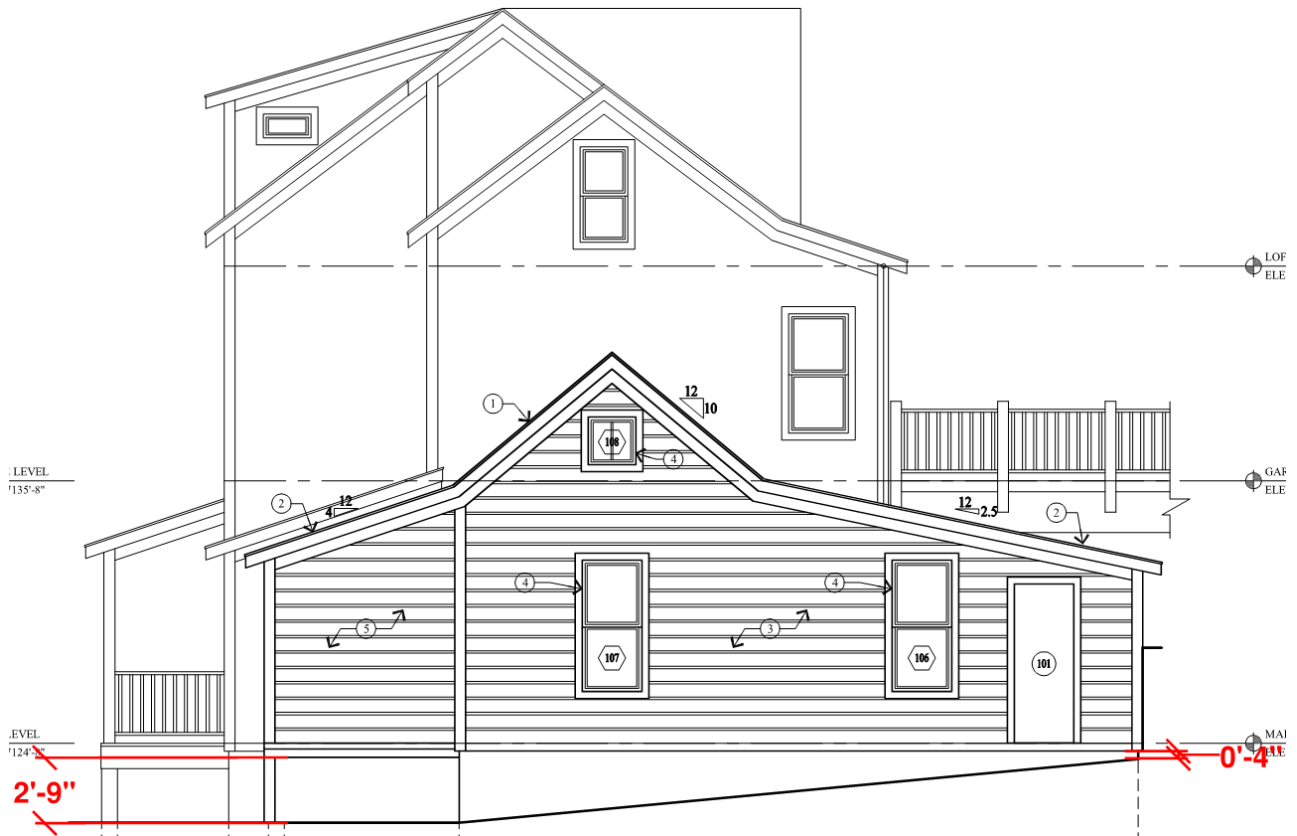
**Figure 12:** Existing Conditions of the North Elevation – Approximate Measurement Of Main Floor Level Above Existing Grade.

Staff finds that the combination of reorientation and lifting (beyond what is specified in the Design Guidelines) results in the loss of Historic scale

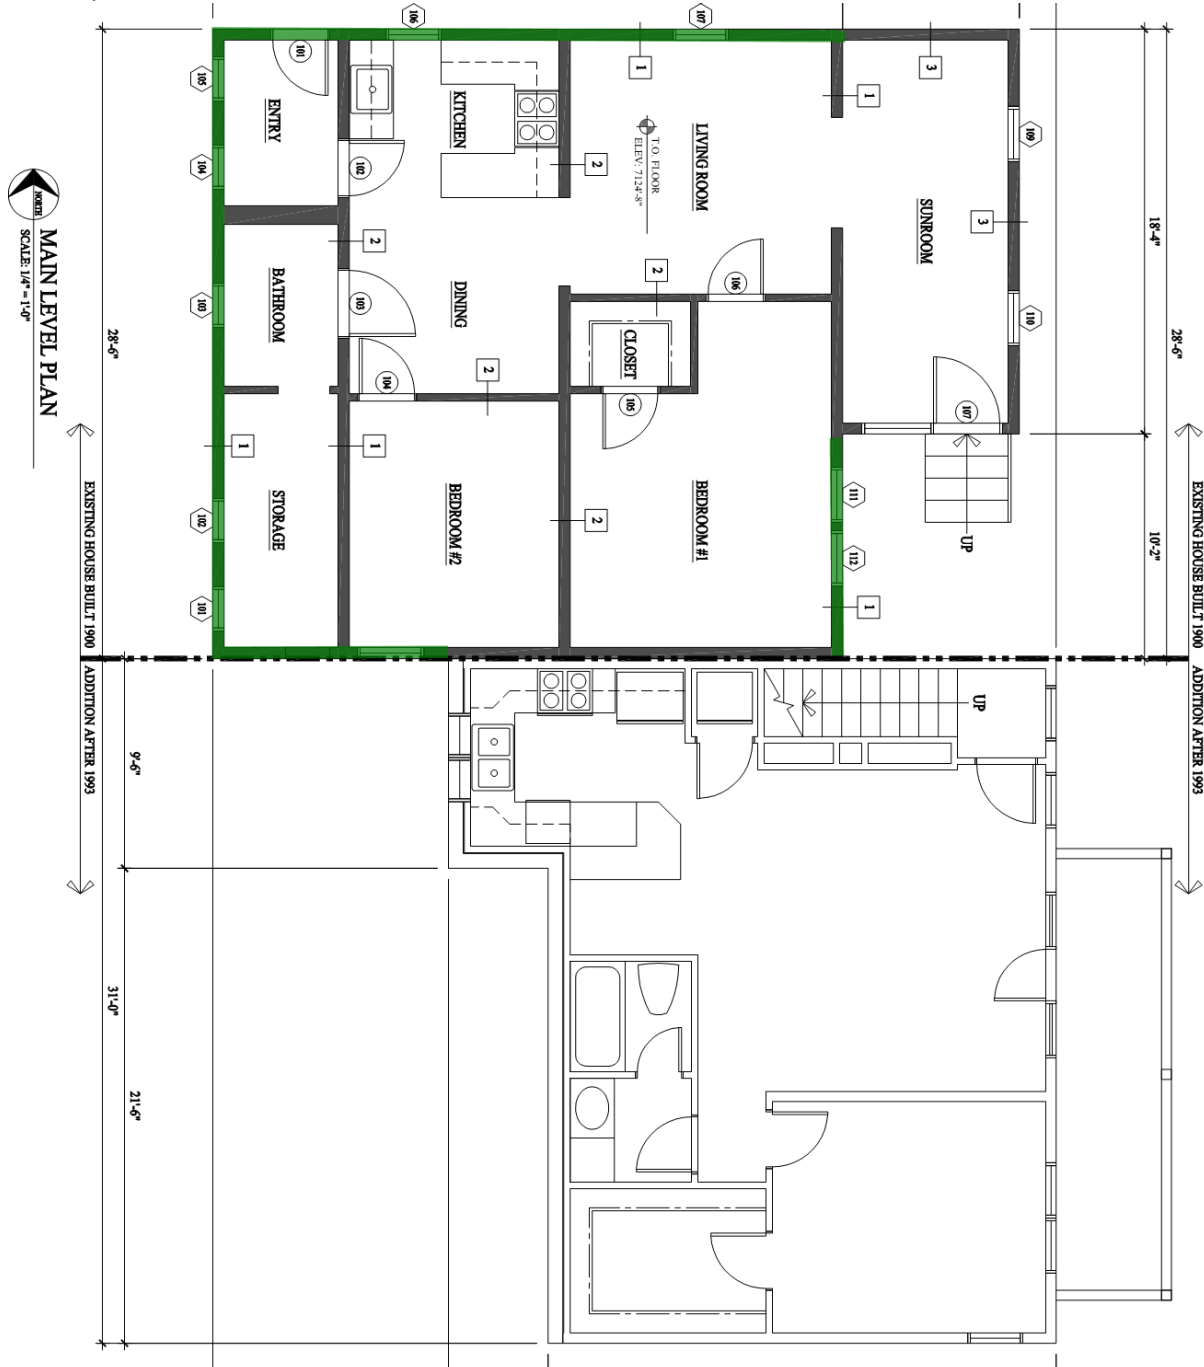
**Figure 14a:** Existing Site Plan identifying the presumed remaining Historic Materials (in green). Drawing has been rotated, north is up and Woodside Avenue is to the left.

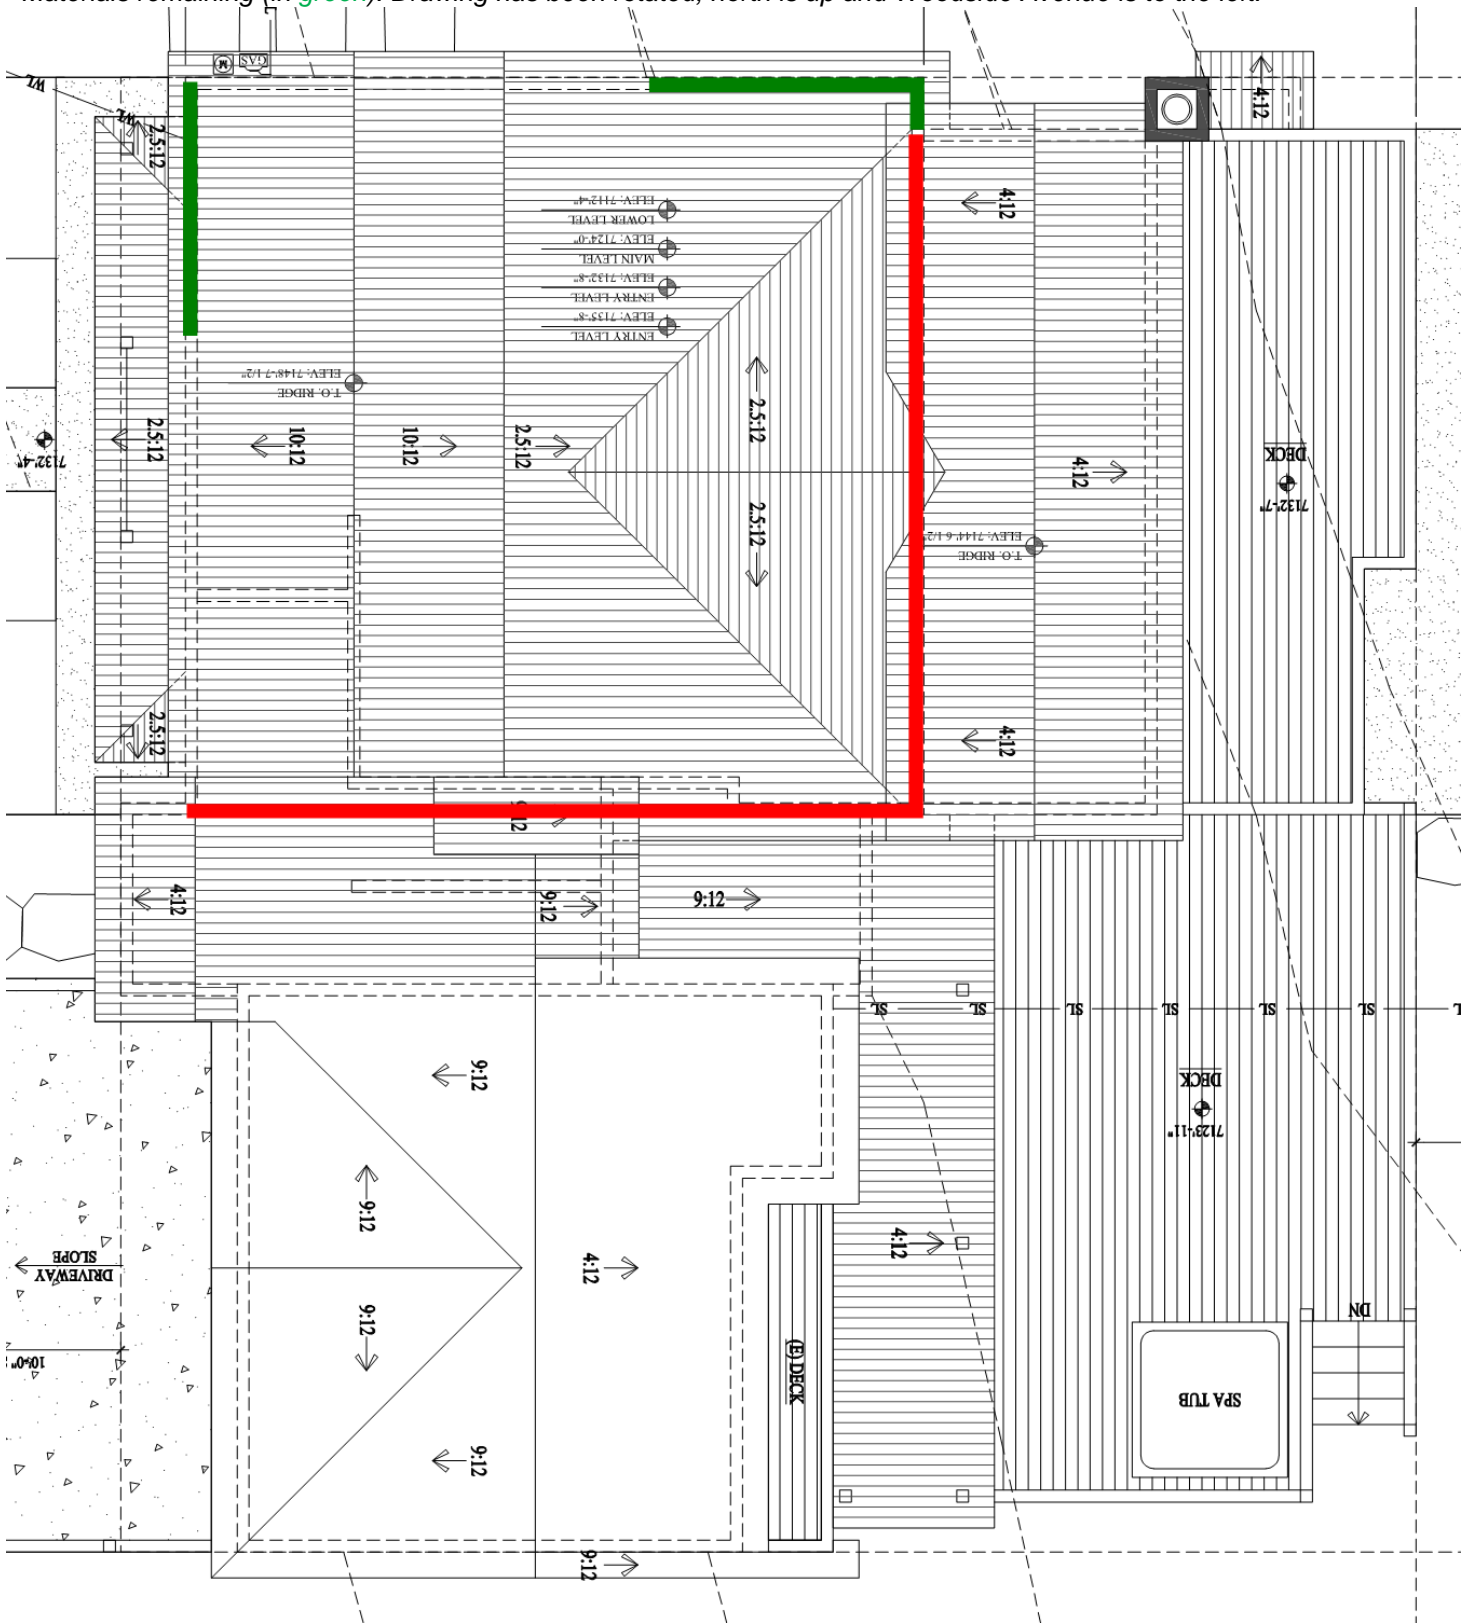
**Figure 14b:** Reoriented the Historic Structure – Presumed Historic Materials Lost (in red). The presumed Historic Materials remaining (in green). Drawing has been rotated, north is up and Woodside Avenue is to the left.

*In summary, if rotated, staff and the Design Review Team find that the Historic Structure will lose the three (3) aspects of Essential Historic Form that this site retains, including, Historic scale, context, and material.*

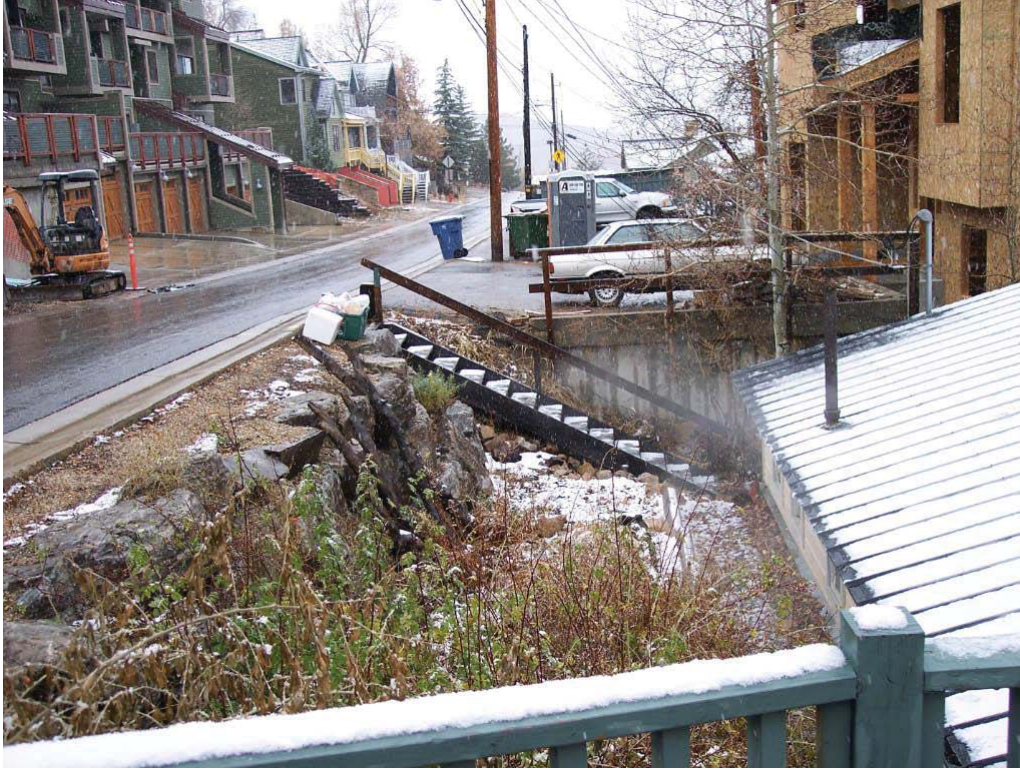
***The front of the property off Woodside Avenue has rock retaining wall that runs parallel with the street. The entry stairs are wood and are in fair shape. Stone walkway leads from the entry to the rear yard. All vegetation is natural and maintained.***

***Rock retaining wall and entry stairs along west elevation***

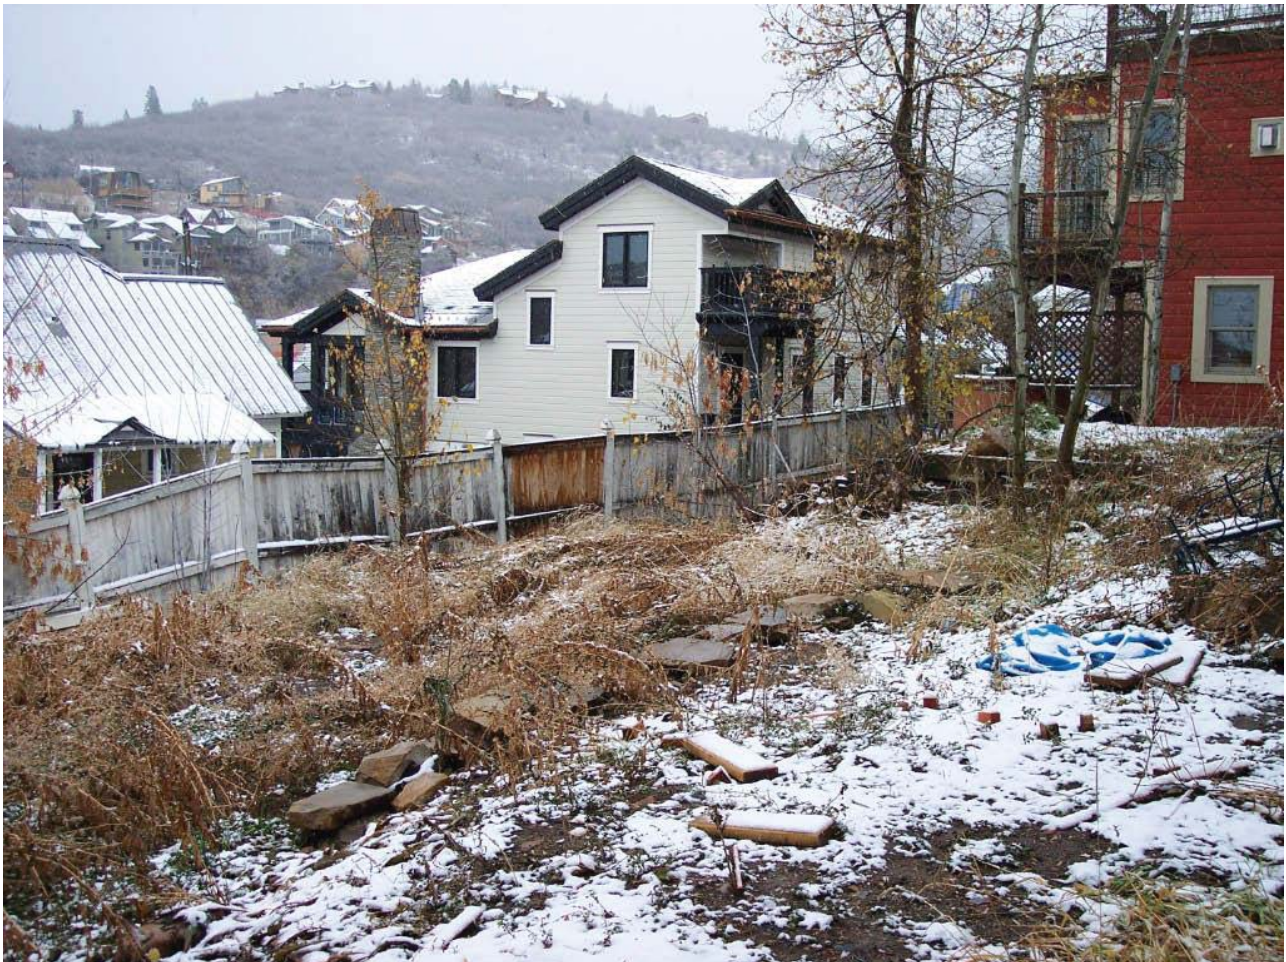
***The rear fence (owned by adjacent property) runs north to south and is 4x4 wood post with 1x4 wood slats in need of repair. The wood fence along the north property line is 6' length sections of 1x6 dog eared cedar slats and in need of repair.***

***Rear yard fence***

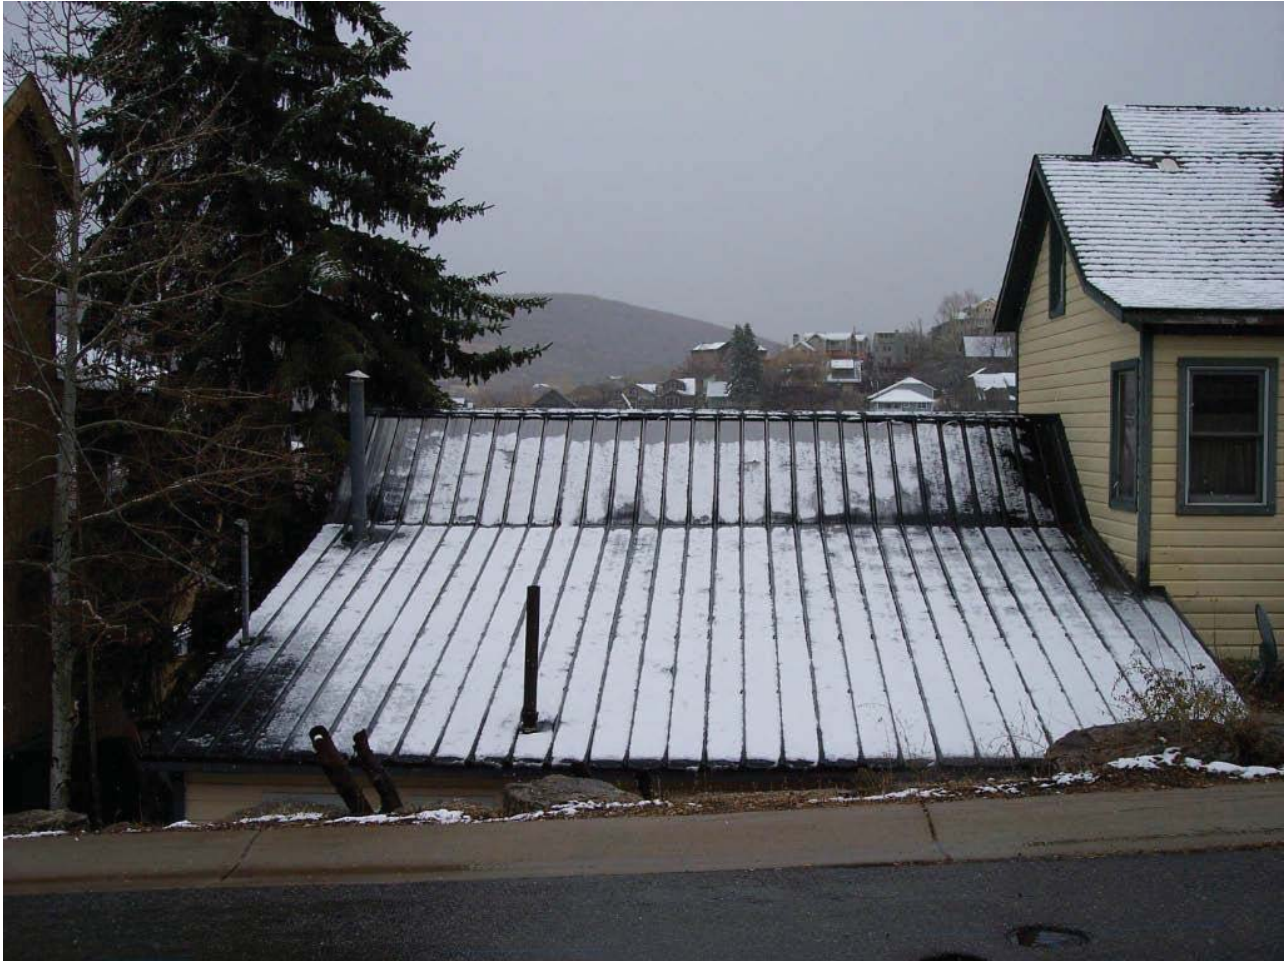
***The roof is simple gable with a 10/12 pitch with a shed running west at a 2.5/12 pitch. This form was the original built about 1900. The shed roof running east off the main gable is a 4/12 pitch and was added after 1978. The roof material is standing seam metal applied after 1978. The main gable form is standing seam metal roof over historic wood shake over historic 1x8 skip plank over historic 2x4 truss at 24" o.c., the truss has 2x4 bottom chord with 1x4 kickers. The two sheds of the gable running east and west were updated after 1978 with standing seam metal over 5/8" plywood over 2x12 joist at 24" o.c.***

***Roof looking east***

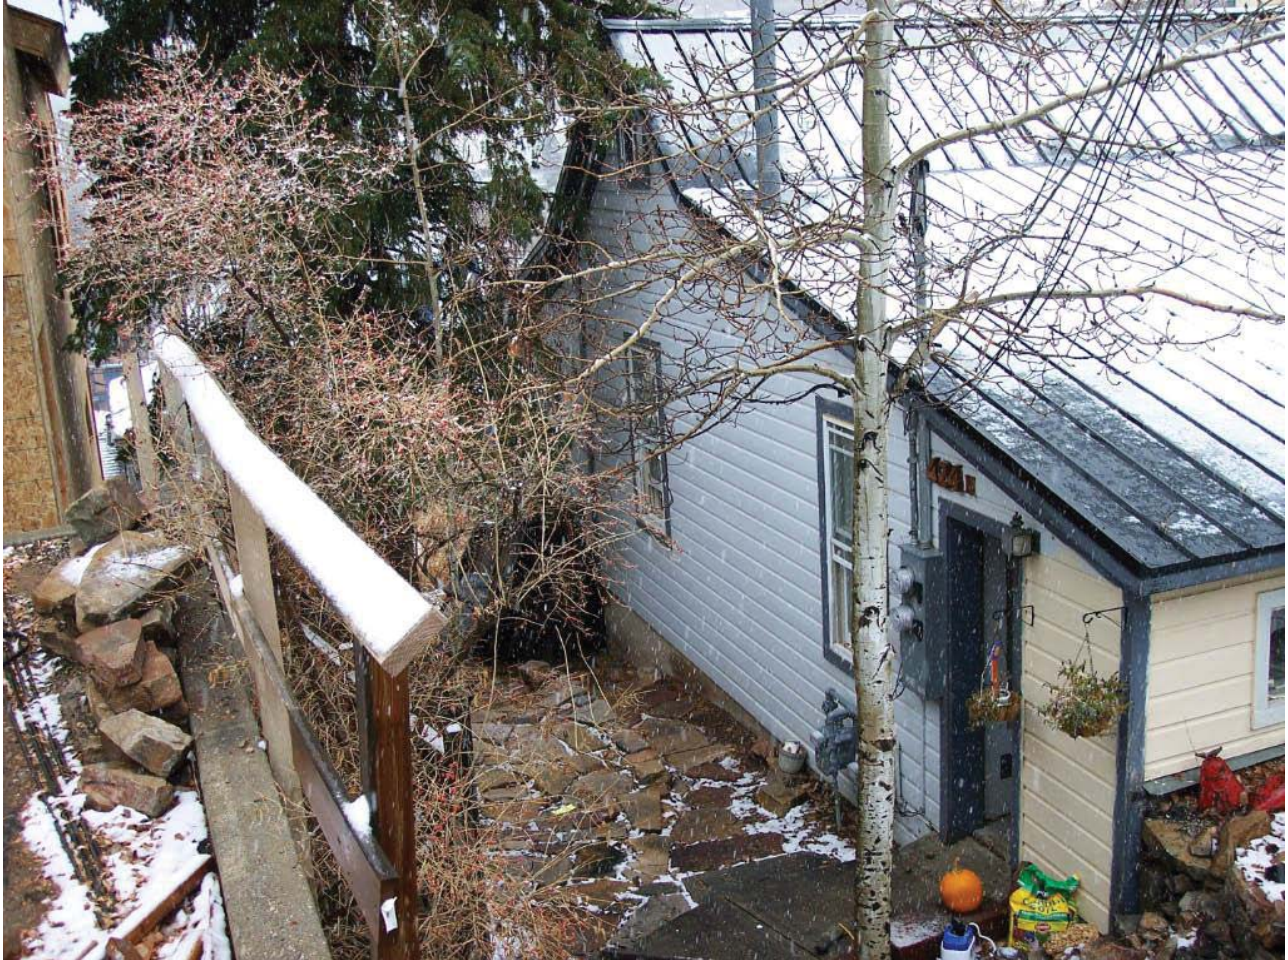
***The north elevation is 1x8 horizontal lap siding applied after 1978, over historic 1x12 vertical plank on 2x4 studs at 24" o.c.***

***North elevation***

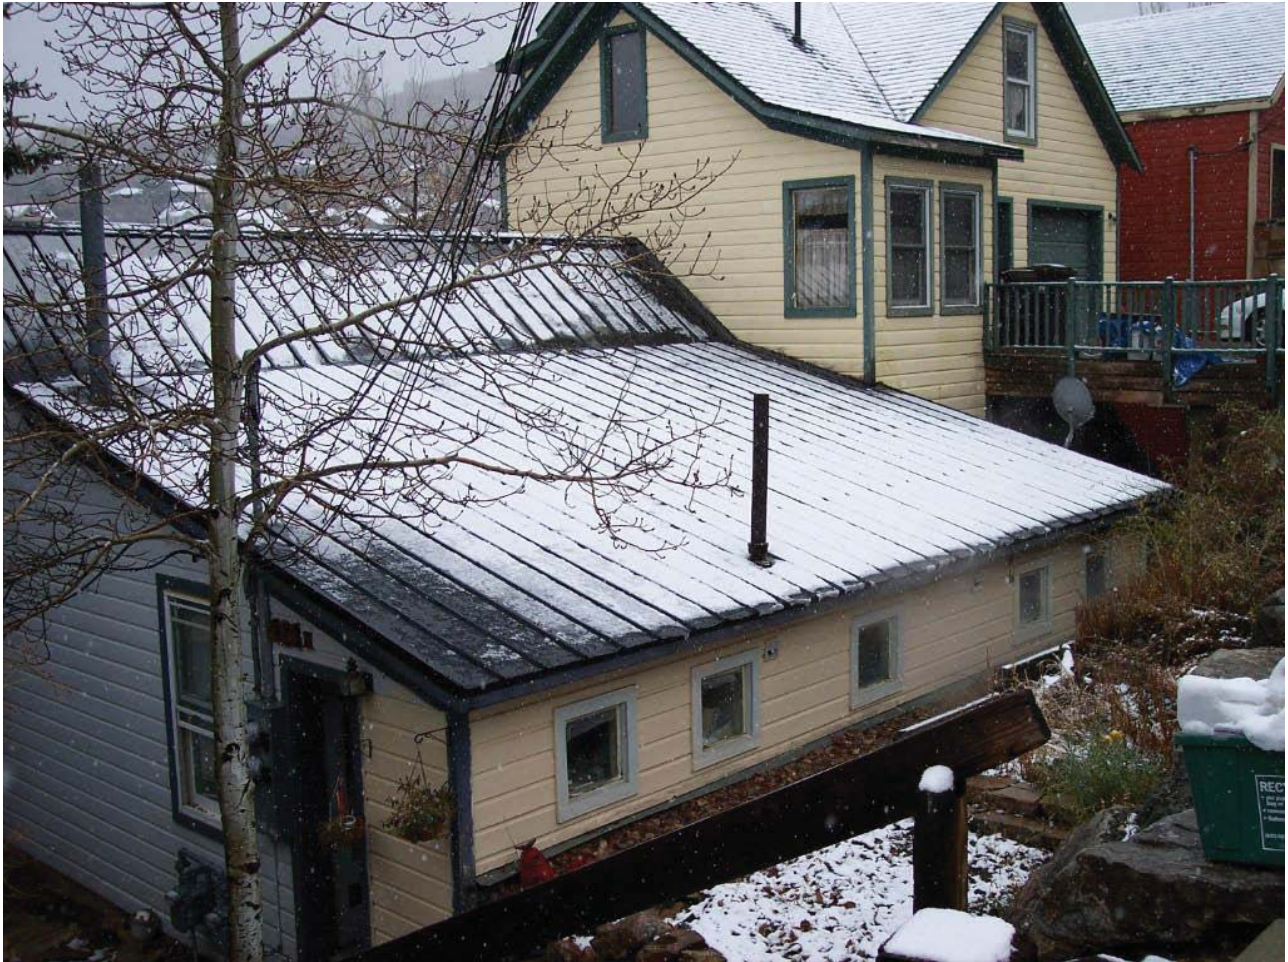
***The west elevation is 1x8 horizontal lap siding applied after 1978, over historic 1x12 vertical plank on 2x4 studs at 24" o.c***

***West elevation***

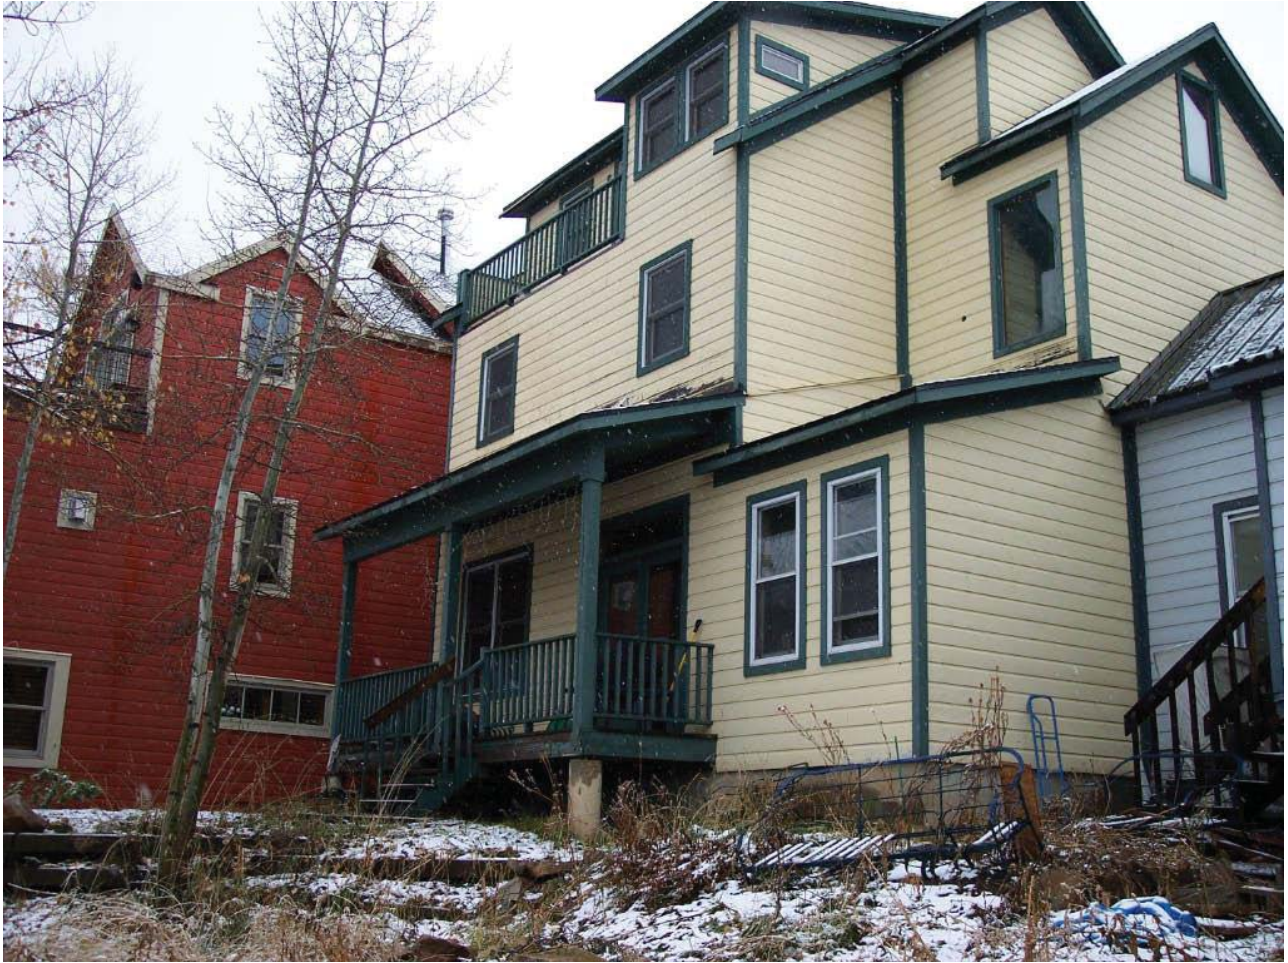
***The south elevation has an addition built after 1993.***

***Addition on the south elevation built after 1993***

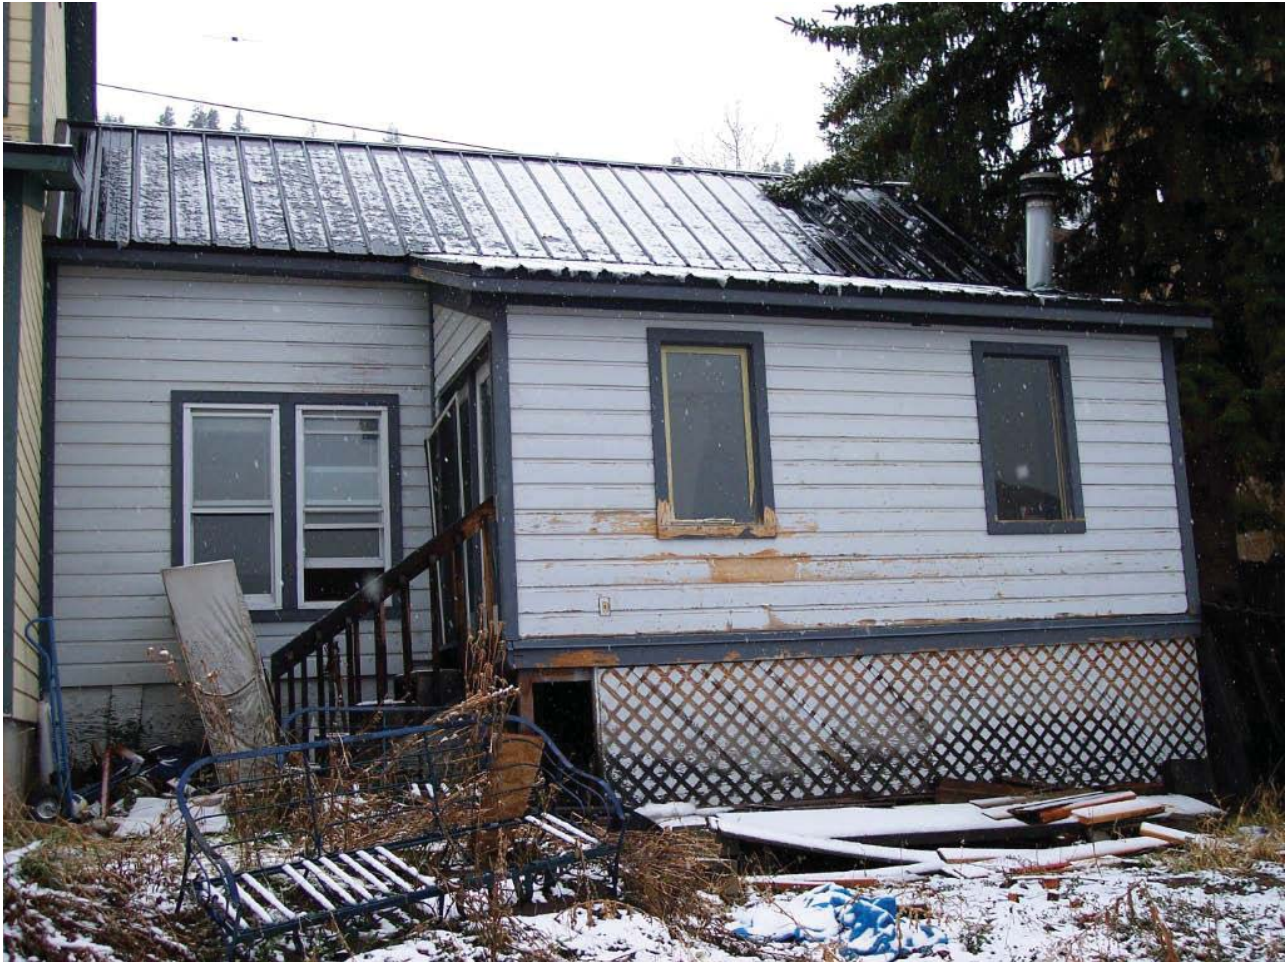
***The east elevation is 1x8 horizontal lap siding applied after 1978, over 5/8" plywood on 2x4 studs at 24" o.c***

***East elevation***

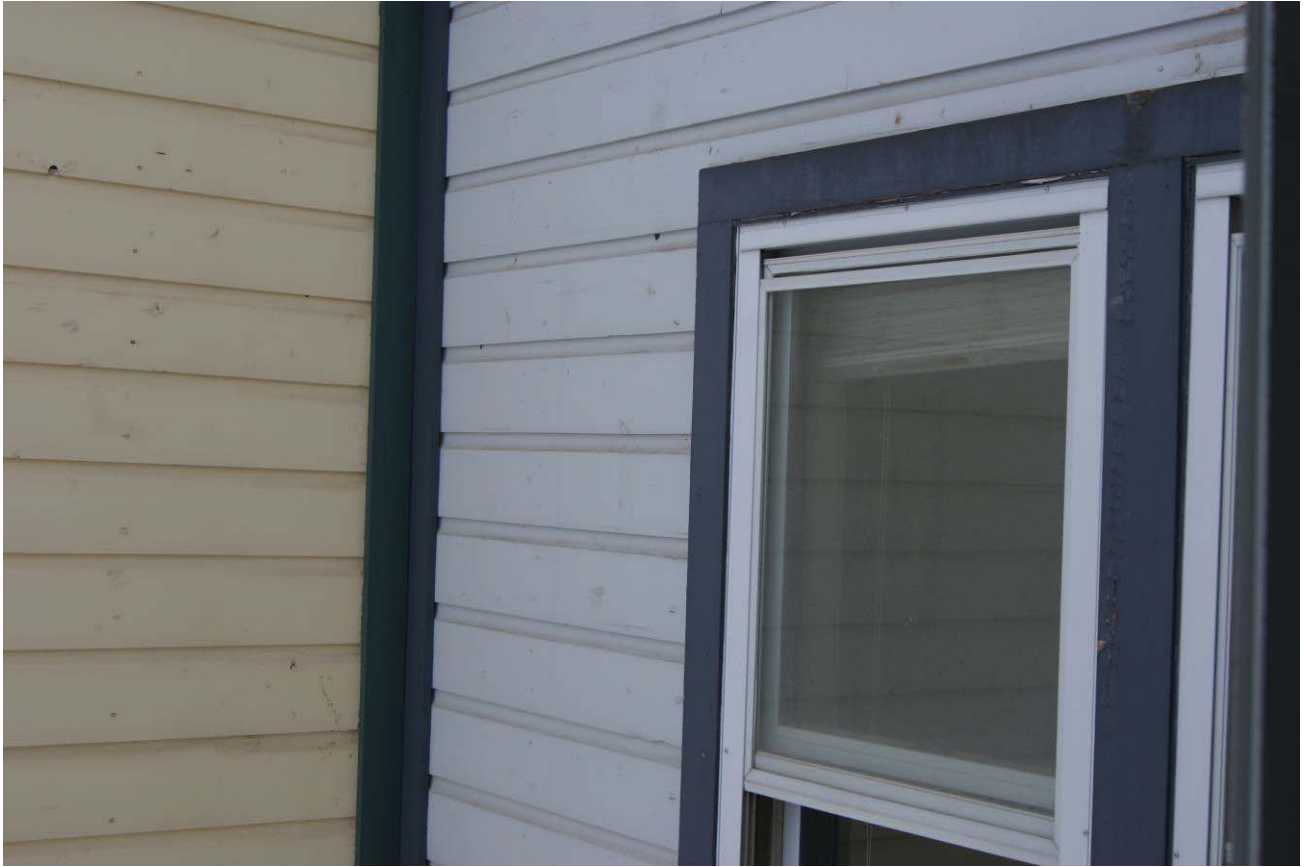
***The windows were updated after 1978 with insulated wood aluminum clad. No historic windows remain.***

***Wood aluminum clad window- typical***

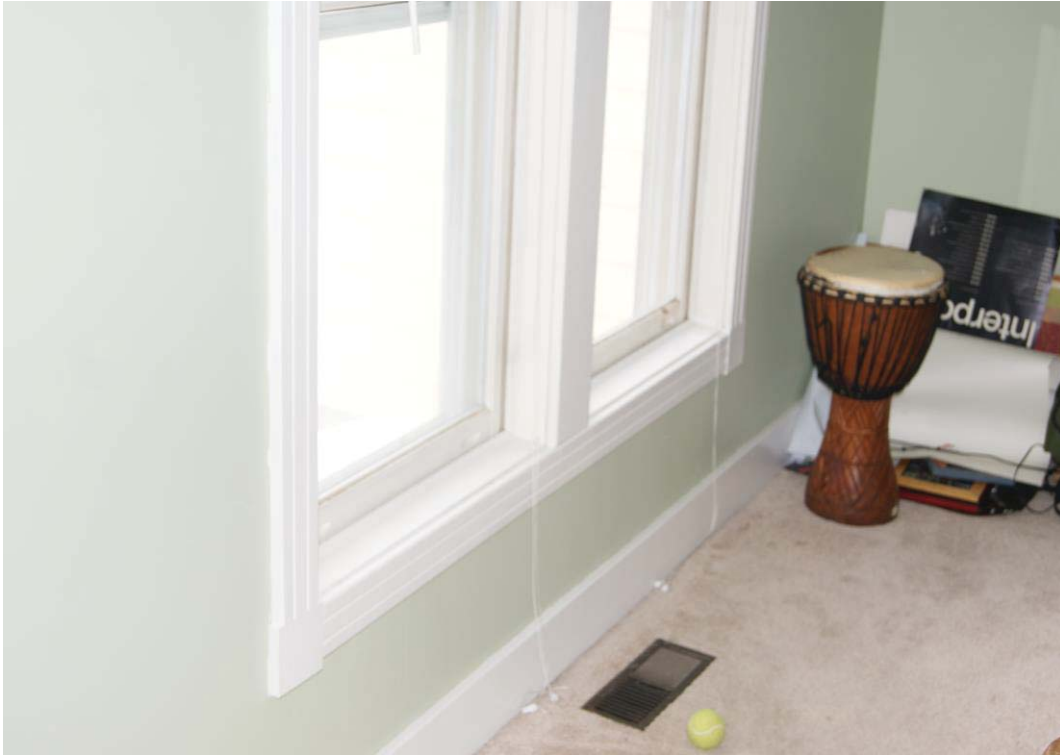
***All exterior and interior trim was replaced after 1978. No historic trim remains.***

***Typical base and window casing***
