# **Exhibit I**

## Applicant's Analysis for Reorientation

Re: Berkley Residence, 424 Woodside

## 424 Woodside, Historic Site Analysis

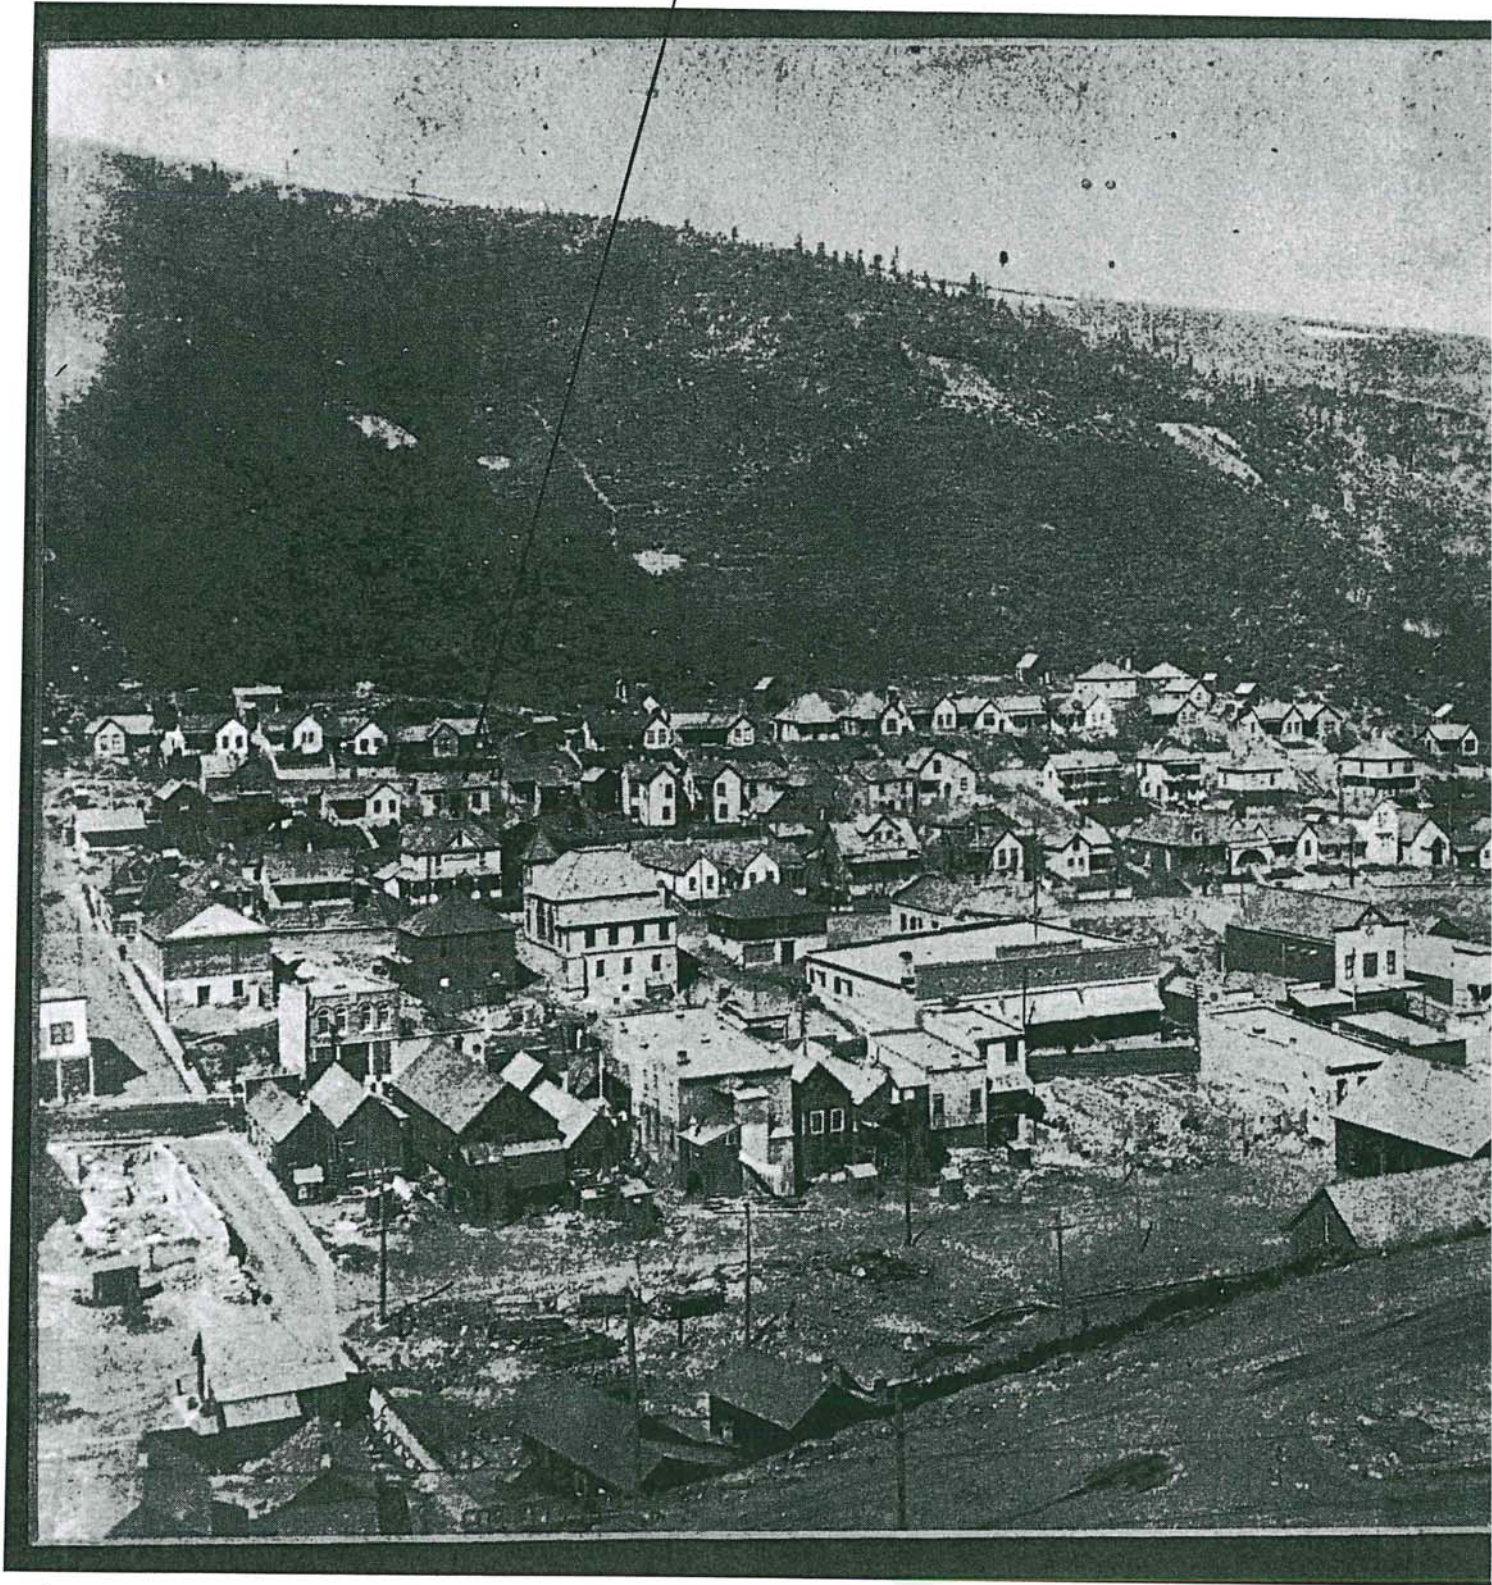
EXHIBIT A  
1907 PHOTO

FOOT PATH

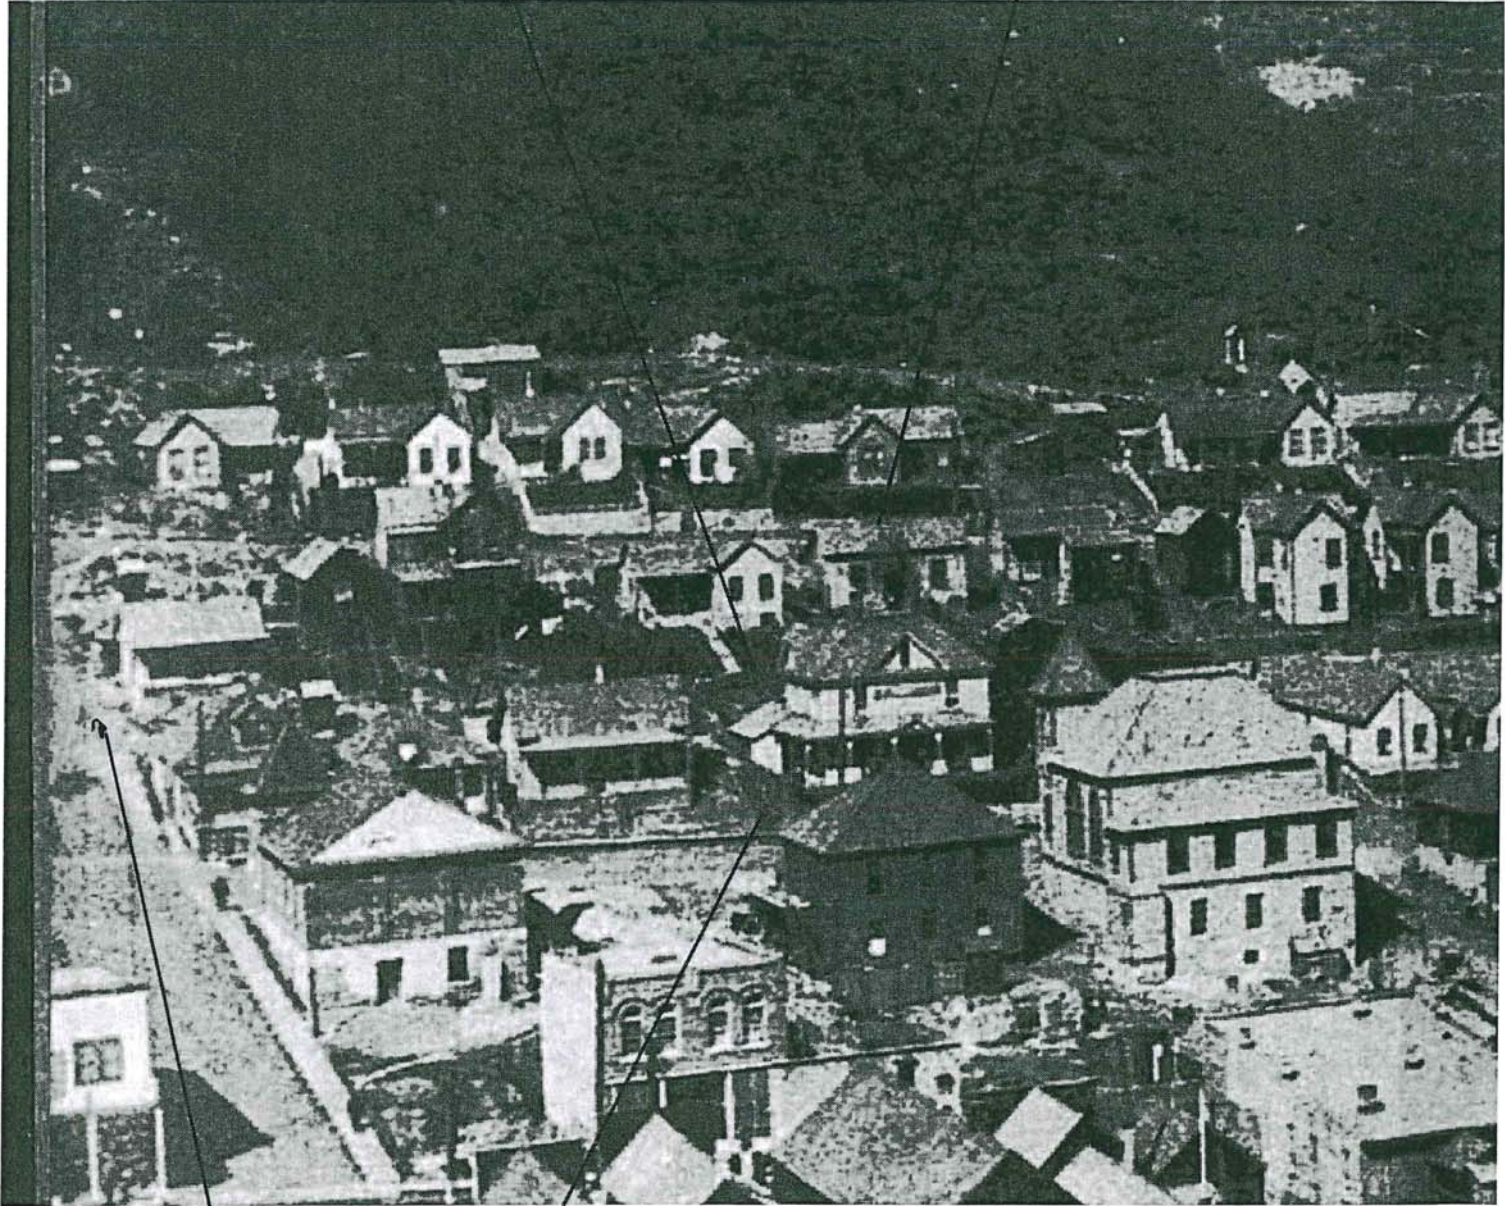
EXHIBIT B  
1907 PHOTO

4TH ST.

STAIR

It is also interesting to note that 4<sup>th</sup> street is actually a street at this point in time with a stair/sidewalk running along its north side, (see Exhibit B). The roadway at 4<sup>th</sup> street is now gone and in its place a public stair.

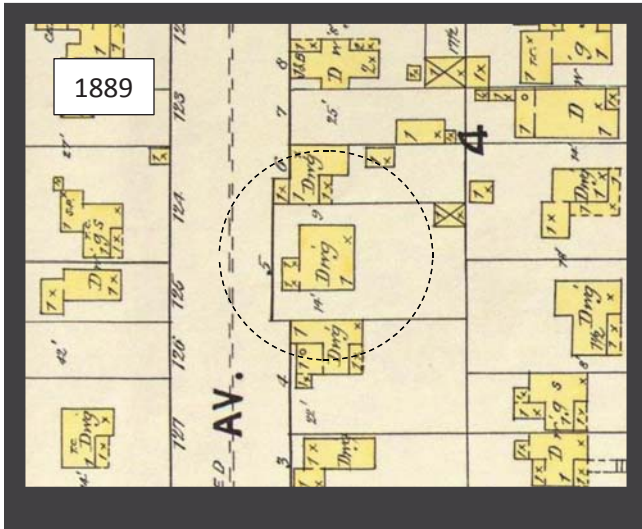
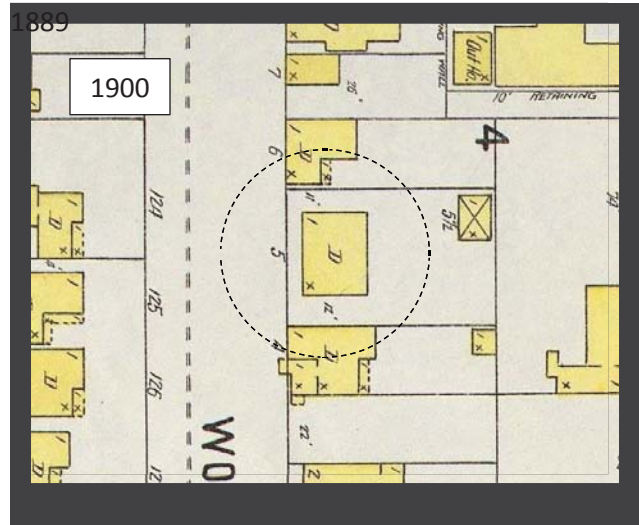
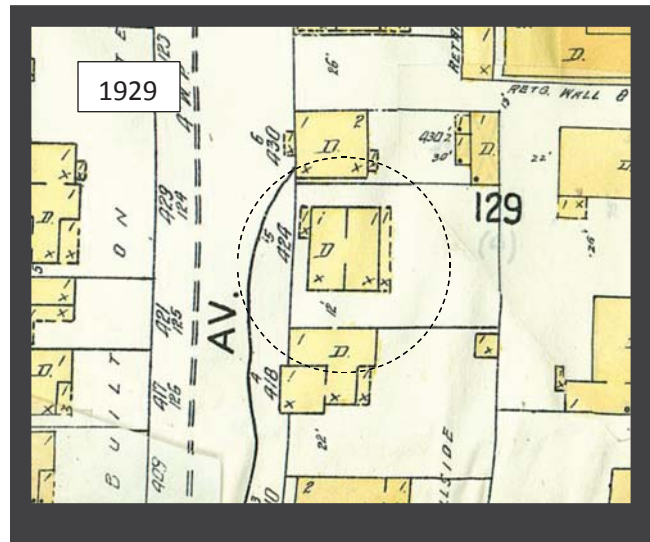
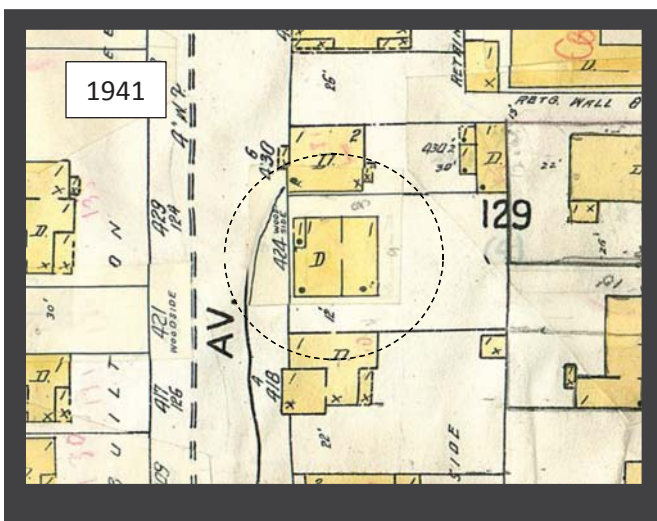
Figure 1. Sanborn Fire Insurance maps showing property at 424 Woodside 1889-1941 (from Carmen 2015).

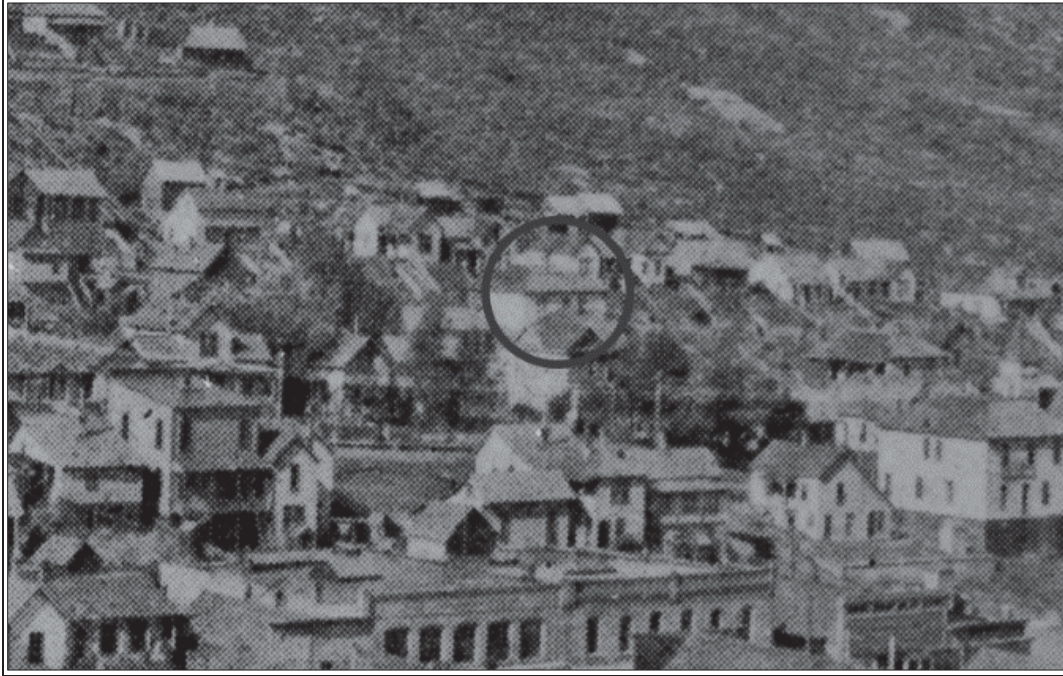
**Figure 2.** View of property at 424 Woodside ca. 1905-1907, facing west-northwest. Note retention of simple hall-parlor form and continued absence of front porch on east side. Photograph no. 1985-6-001.

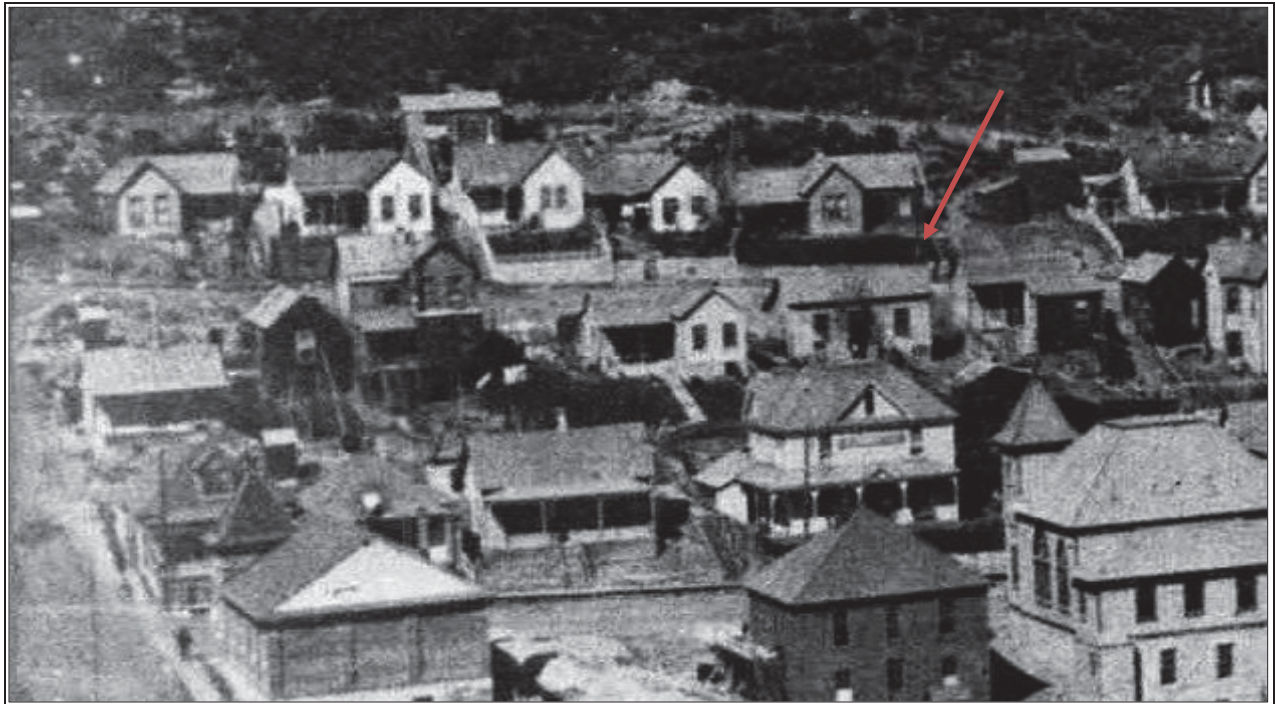
**Figure 3.** View of property at 424 Woodside in 1907, facing west-northwest. Note simple hall-parlor form, east-facing aspect with a view across canyon, and access via a footpath leading north from Fourth Street behind the Park Avenue houses. Note the absence of a front porch on east side, although according to the 1907 Sanborn map a porch was added in this year. Also note the mix of house orientations along the downhill (east) side of Woodside, with some facing the street and others the canyon. Photograph provided by Jonathan DeGray.

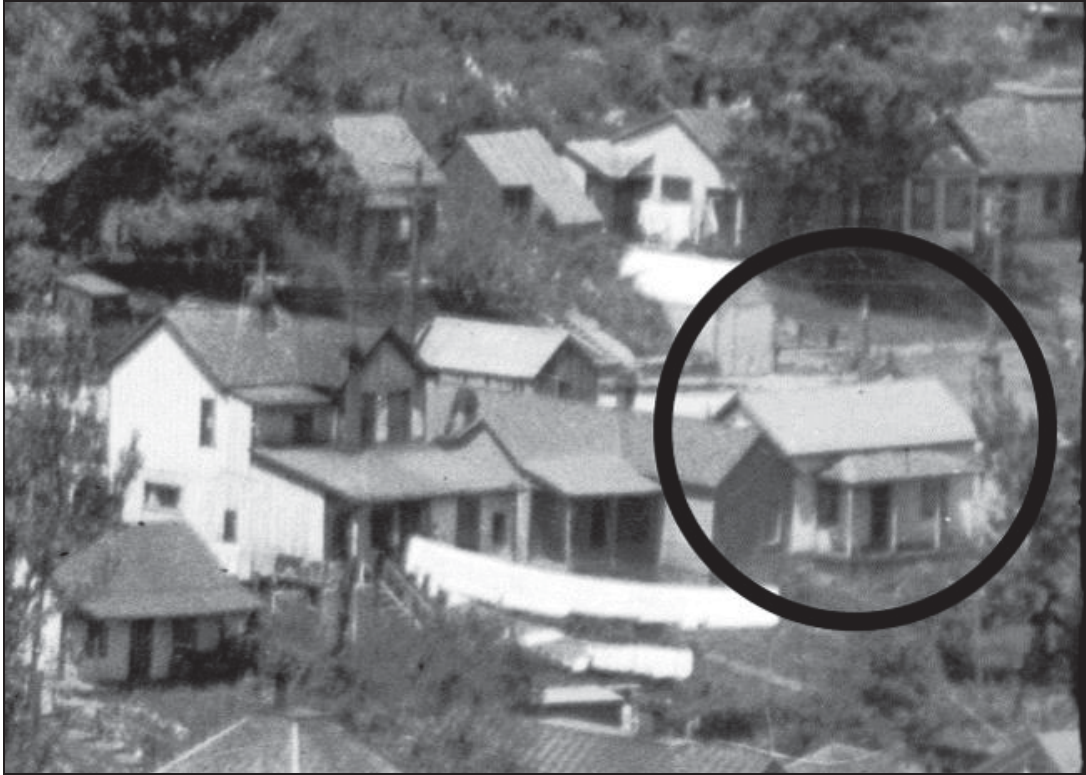
**Figure 4.** View of property at 424 Woodside in 1930, facing northwest. Note the retention of the simple hall-parlor form and addition of hip-roofed front porch, which was removed by 1941 according to the Sanborn map. Photograph no. 1987-2-134.

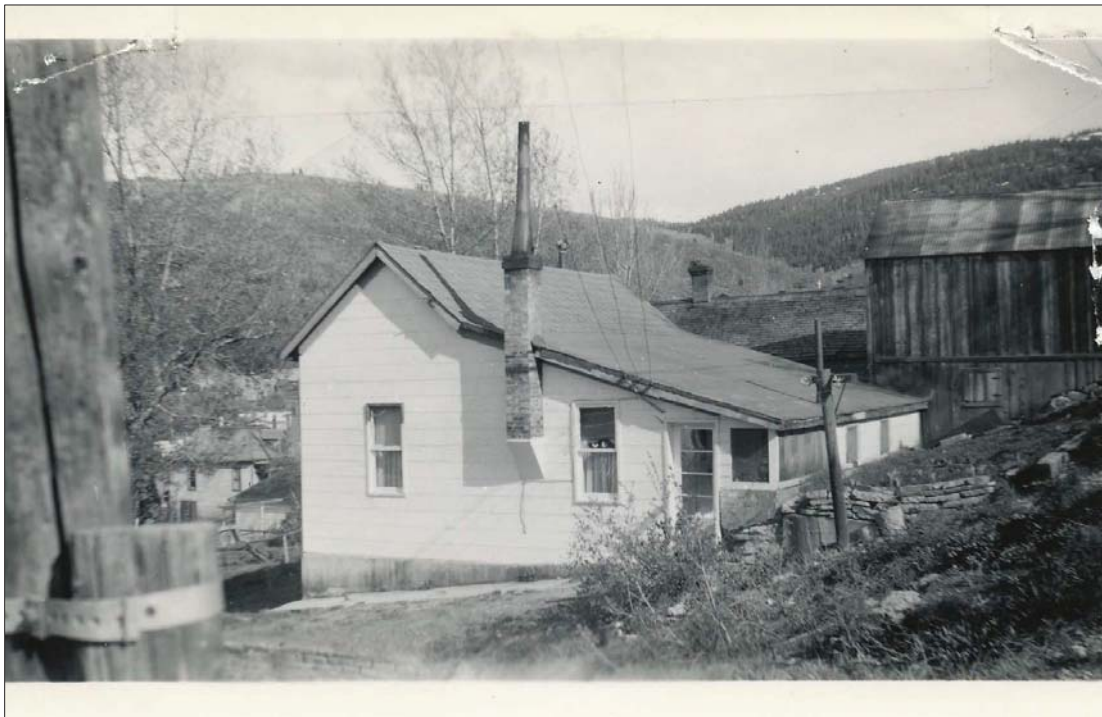
**Figure 5.** Tax appraisal photograph of property at 424 Woodside dating to ca. 1941, facing southeast.

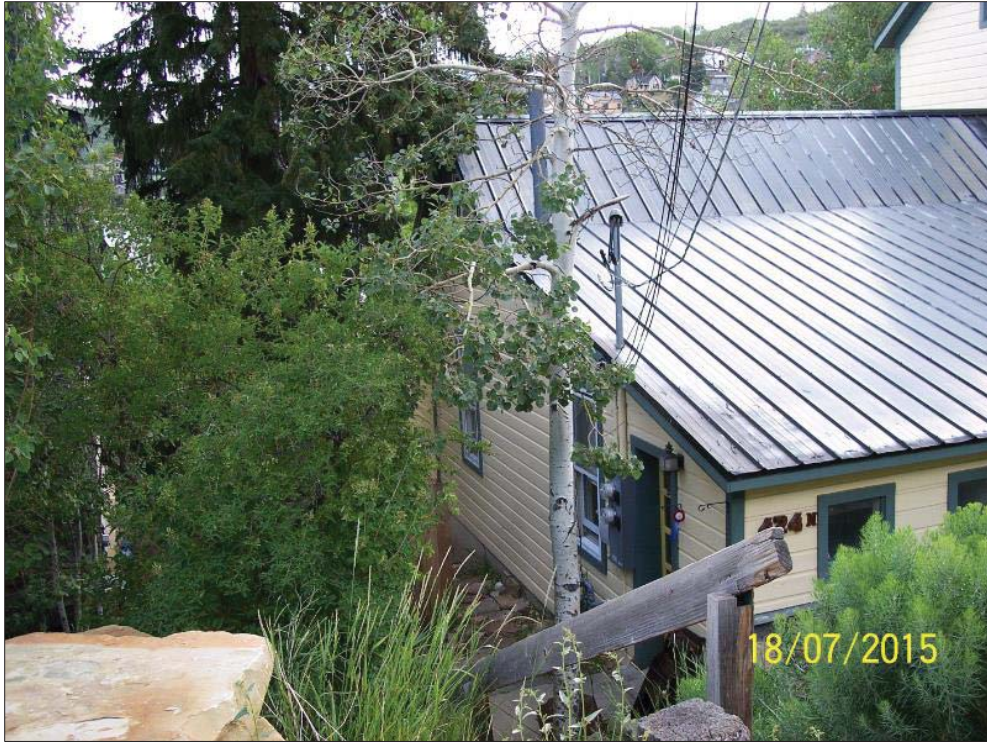
**Figure 6.** North and west sides of historic house at 424 Woodside, facing east-southeast, 2015.

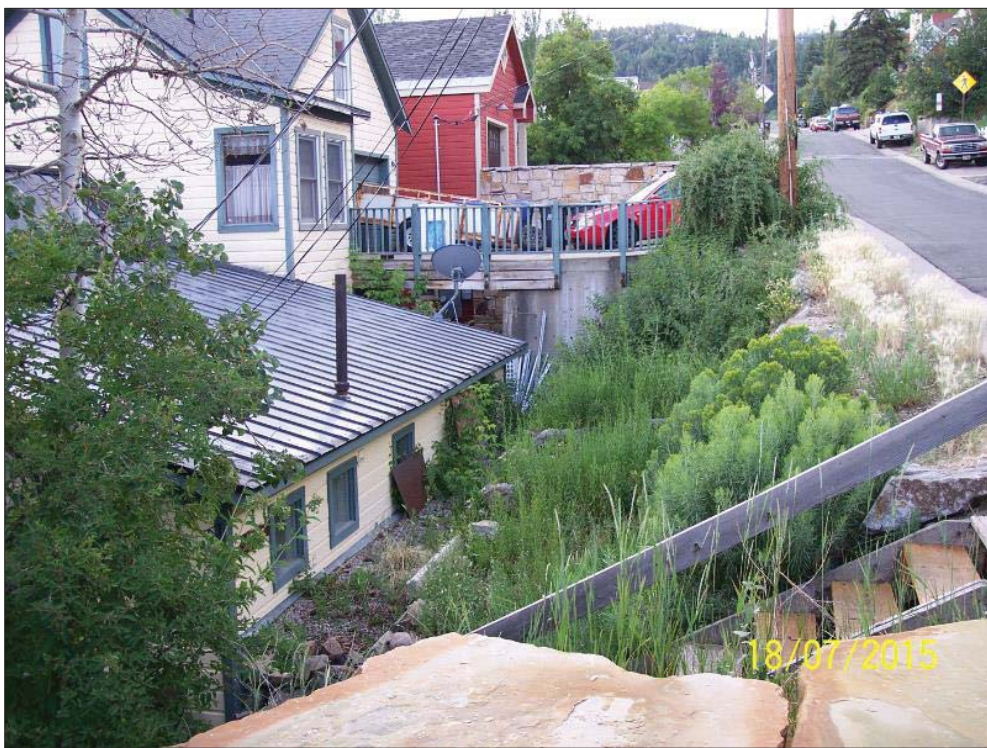
**Figure 7.** West side of historic house at 424 Woodside, facing south, 2015. South addition dating to 1993 is visible at upper left.
