**PARK CITY MUNICIPAL CORPORATION
HISTORIC PRESERVATION BOARD
SPECIAL MEETING
CITY COUNCIL CHAMBERS
January 16, 2018**

269 Daly Avenue – HDDR Material Deconstruction and Reconstruction – The applicant is proposing to reconstruct the historic house and historic garage designated as “Significant” on the City’s Historic Sites Inventory. In addition the applicant will be removing existing non-historic fences, a non-historic addition on the southwest corner of the house, the roof structure, one deteriorated chimney, exterior walls and layers of non-historic siding, non-historic front porch, non-original front door, and non-historic windows on the historic house. The applicant is only proposing to modify the garage doors as part of the reconstruction of the historic garage.

269 Daly Avenue Developmental History:

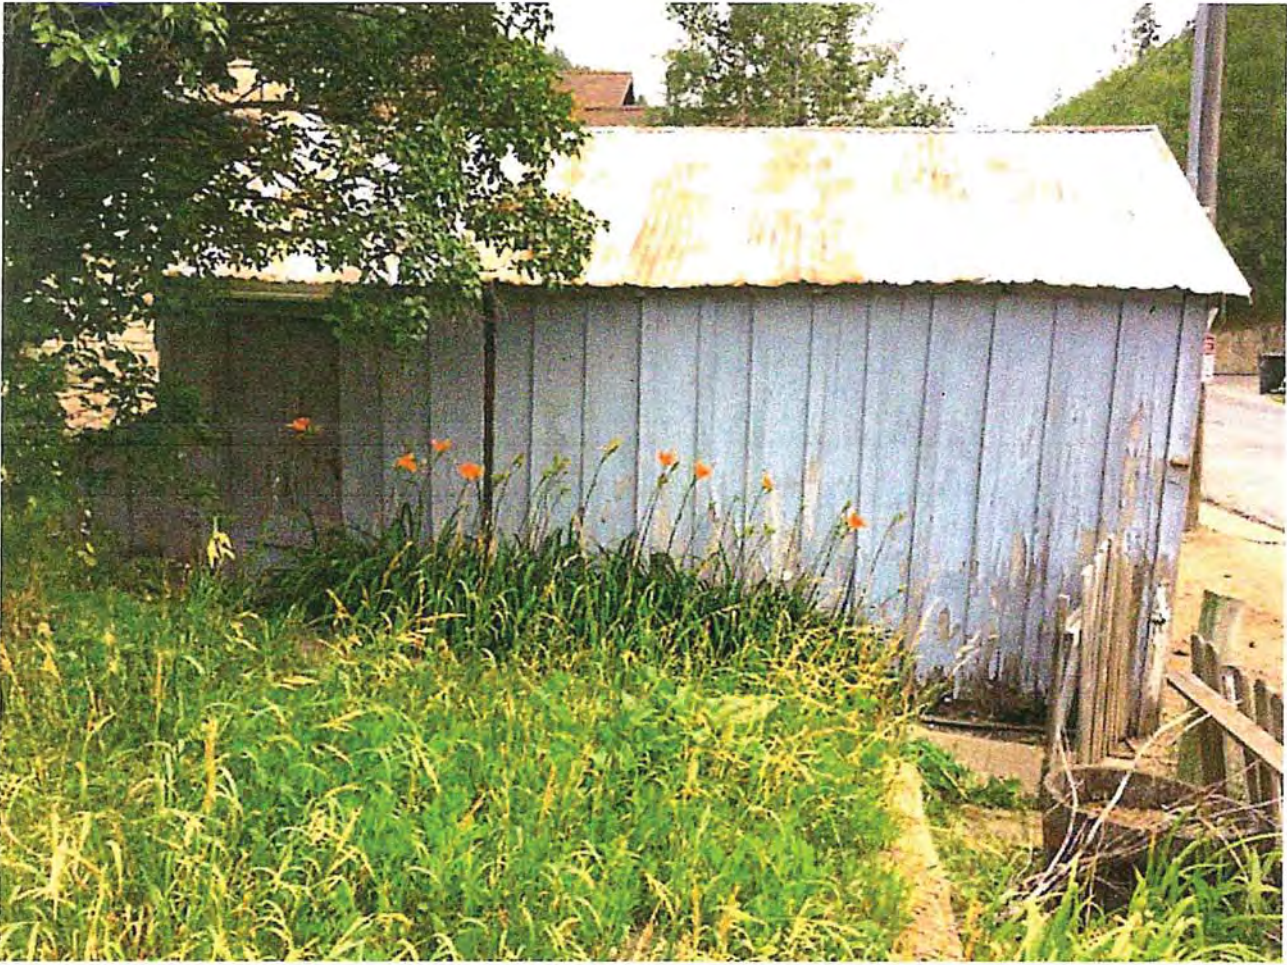
PHOTO #3

Grade has been built up at base of wall so water damage is evident at base of wall. Viewing photo #4, settlement is also evident
